SAFETY INVESTIGATION REPORT

REPORT NO.: 22/2018

MV BOZDAG **Deck slewing crane failure** **in the port of Tallinn** **28 November 2017**

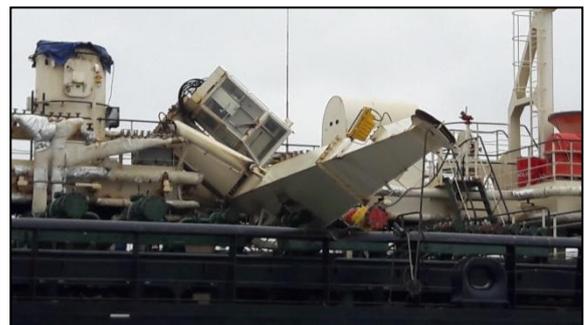
By this time, the bags were about 2.0 m above the quay. It was during this time that a very heavy impact noise was heard and the deck slewing crane’s jib just collapsed and rested against the bulwark on the port side (Figures 1 and 2). The test had not yet been carried out with 125% load but a 100% (10 tonnes) load test was being applied.

Figure 1: The collapsed deck slewing crane

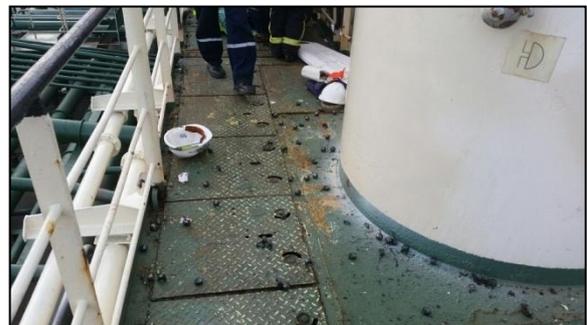
Figure 2: Parts of the slewing bearing following the collapse

Finally, the combination of the increase in dynamic loading and the force due to sudden halting, would have been enough to cause the structure to fail before the braking system would fail again. This would cause the weakest load bearing point (which in this

case was the slewing bearing) to fail, forcing the upper deck slewing crane structure to fall on the deck.

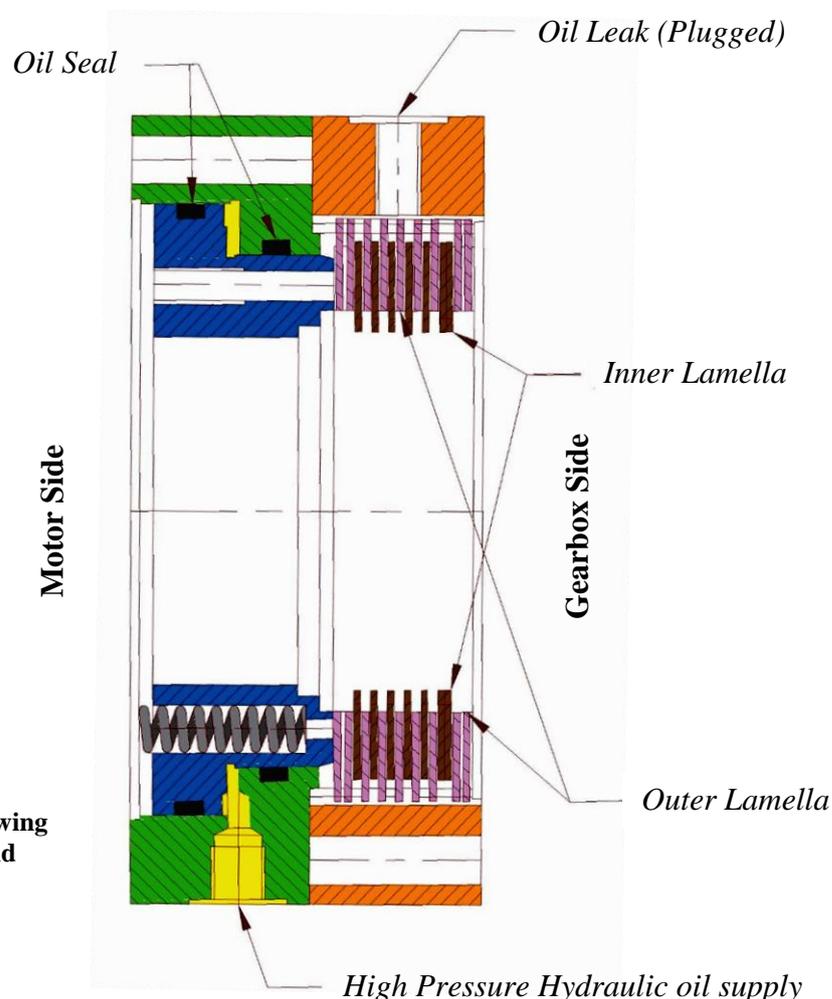
Figure 6: Schematic drawing of the brake assembly and hydraulic supply

The system comprised of a high pressure hydraulic actuating system (blue shading). The yellow shade shows the supply of hydraulic oil. The braking system was set to be normally engaged and by an increase in the hydraulic pressure, the actuator was pushed towards the motor side, compressing the springs (16 in total), which would return the actuator to its initial position when the pressure of the hydraulic was relieved.

Two oil seals on both ends of the actuator were fitted to hold any hydraulic oil from leaking either to the disk brakes' housing or the motor. A plug (marked as 'oil leak' in Figure 6 and shown in Figure 7), was also fitted inside the brake housing, serving as a tell-tale, should there be an oil leak as a result of an oil seal failure. The tell-tale was not open to atmosphere but plugged, thereby ensuring that dirt and water ingress inside the brake housing was prevented as this would have otherwise compromised the brake's performance.

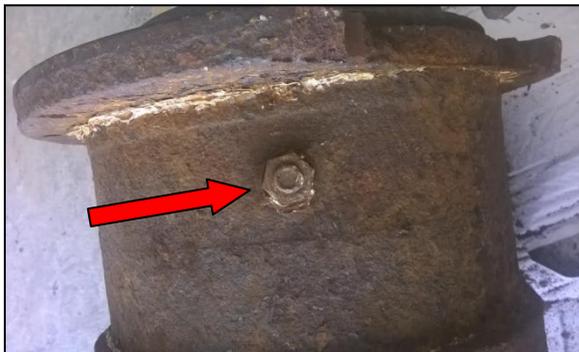
Figure 7: Plugged tell-tale (after cleaning of the brake housing)

If the plug is not checked on a regular basis, any hydraulic fluid which may have leaked past the inner oil seal would go unnoticed from the exterior of the disk brake system.

The safety investigation noticed that the brake assembly inspection / testing had not been included in the maintenance programme. Moreover, there was no reference to the tell-tale opening on the assembly and any leaking hydraulic oil went undetected. The amount of flaking corrosion, layers of paint on the housing and rounded Allen bolt heads suggested that the brake assembly had not been opened for several years.

22/2018_R1 Review its maintenance programme for the deck slewing crane and ensure that procedures are included for the rocking test of the slewing bearing and the inspection of the braking system assembly.

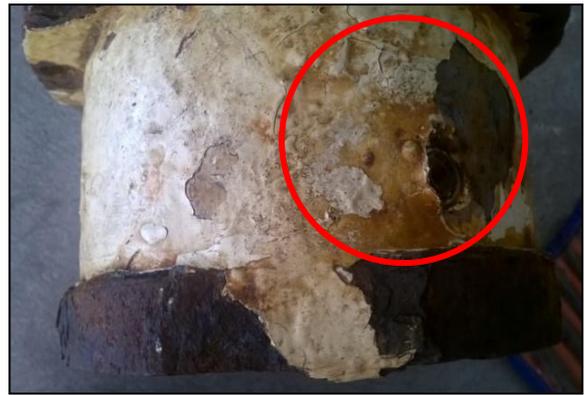
An initial inspection of the brake assembly when it was first received revealed multiple layers of paint. The housing itself had significant levels of corrosion with flakes of material chipping away during the cleaning process (Figure 8).

Figure 8: Layers of paint and corrosion

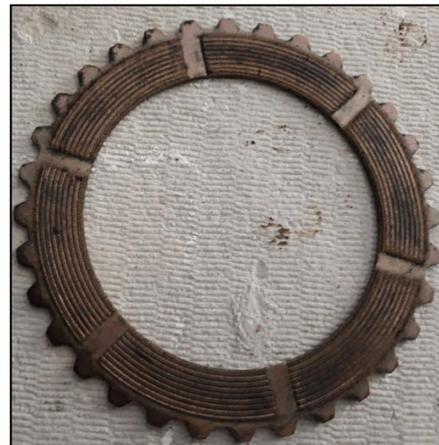
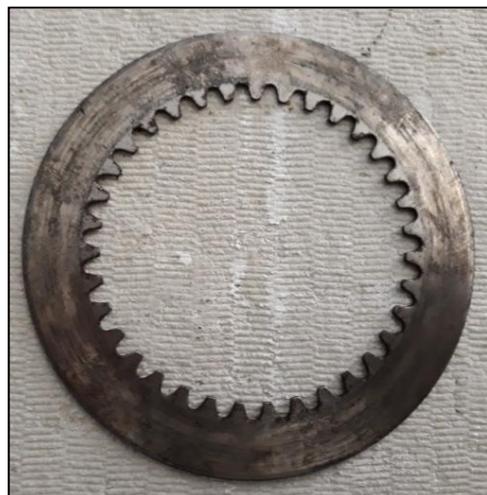
Following disassembly, the internal inspection of the brake system revealed two main problems. It was immediately evident that the inner and outer lamellas (Figures 9 and 10) were 'smeared' with hydraulic fluid.

Figure 9: Outer lamella (nine in total)

Figure 10: Inner lamella (eight in total)

As the hydraulic fluid contaminated the brake surfaces, it would have formed a coating which had a coefficient of friction that was extremely low when compared to the designed coefficient of the disk brake compound.

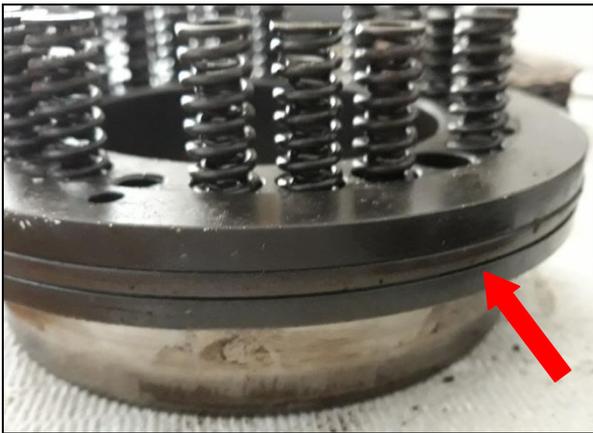
The safety investigation did not exclude that due to a worn oil seal on the high pressure hydraulic actuating system⁸ (Figure 11) the brake system could have been contaminated with hydraulic fluid and when the winch was operated (and the hydraulic pressure is therefore increased and the brake discs are pushed apart from each other) the brake lining surfaces became exposed and contaminated with hydraulic fluid, hence compromising the braking capacity of the system, when the brake engaged again as soon as the hydraulic pressure was relieved.

Figure 11: Oil seal fitted on the high pressure hydraulic actuating system

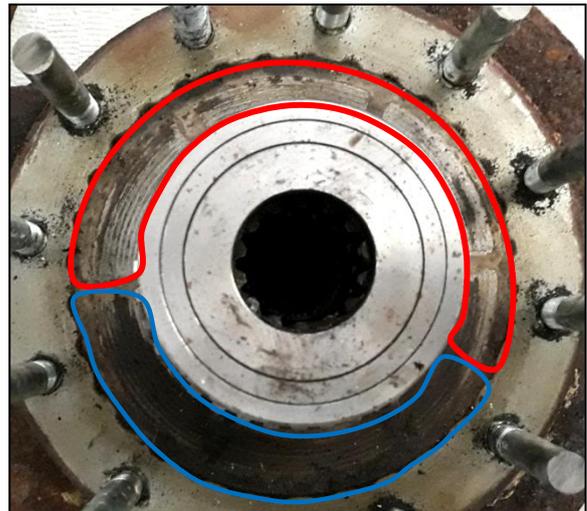
Once disassembled, it also appeared that the wear was uneven on at least three of the outer lamella sections. Figure 12 shows the innermost outer lamella. Whilst the safety investigation could not establish the reason behind the uneven wear, it was not excluded that the friction faces were not 100% in contact, thereby also compromising the braking capacity of the system.

Figure 12: Uneven pressure marks on the innermost outer lamella friction surface
