Report on the investigation of  
the engine failure and fire on board  
the ro-ro cargo vessel

***Finlandia Seaways***

11 miles east of Lowestoft

16 April 2018

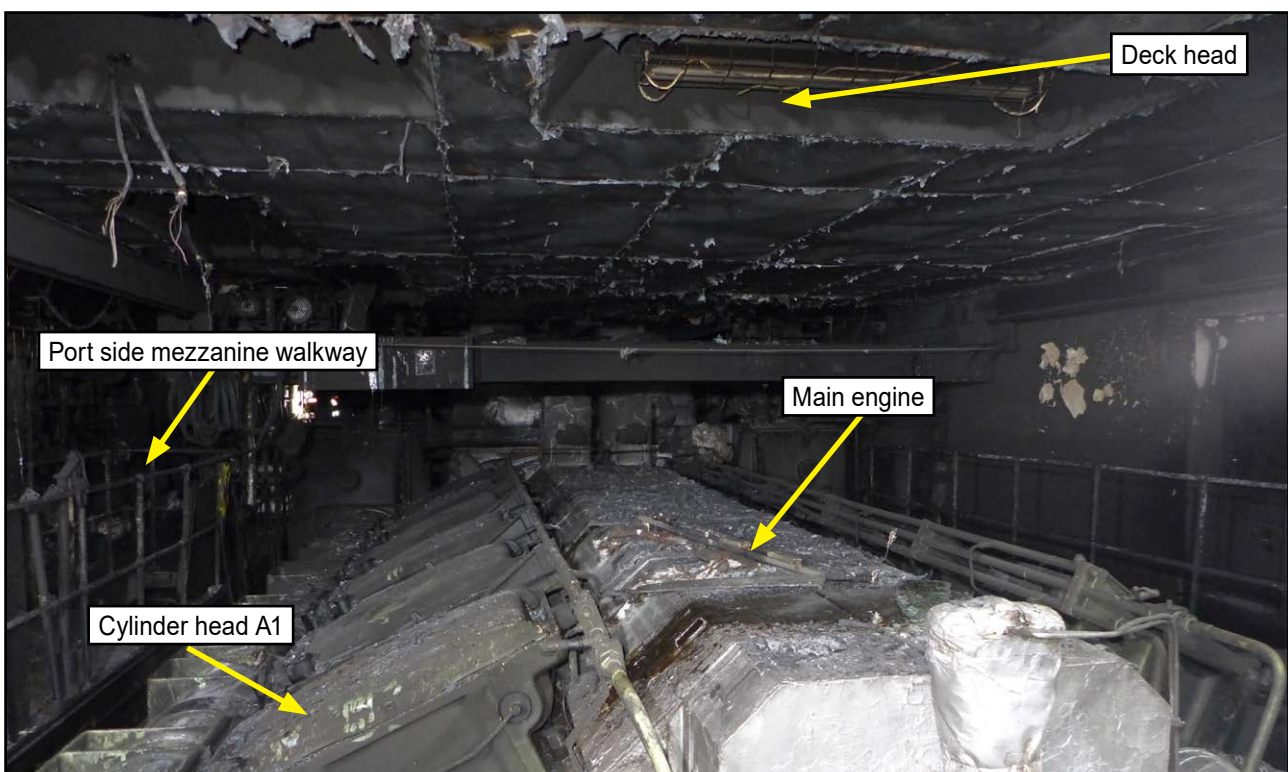
**Figure 12:** Fire damage to upper engine room (looking forward)

Fire damage was sustained primarily at the tween deck level in the engine room, with severe heat damage to the upper part of the main engine and engine room deckhead (**Figure 12**). Most of the heat damage was sustained around the main engine cylinder heads, and to auxiliary equipment on the periphery at the forward end of the engine room. Further aft, towards the two auxiliary generators, smoke damage was the major contributor.

On the bottom plates, the main area of heat damage was at the port forward engine room access door and the adjoining stairwell. Impact damage to the access door caused by the components ejected from the main engine had enabled heat and smoke to enter the stairwell, which had then funnelled up the next two decks to the ECR.

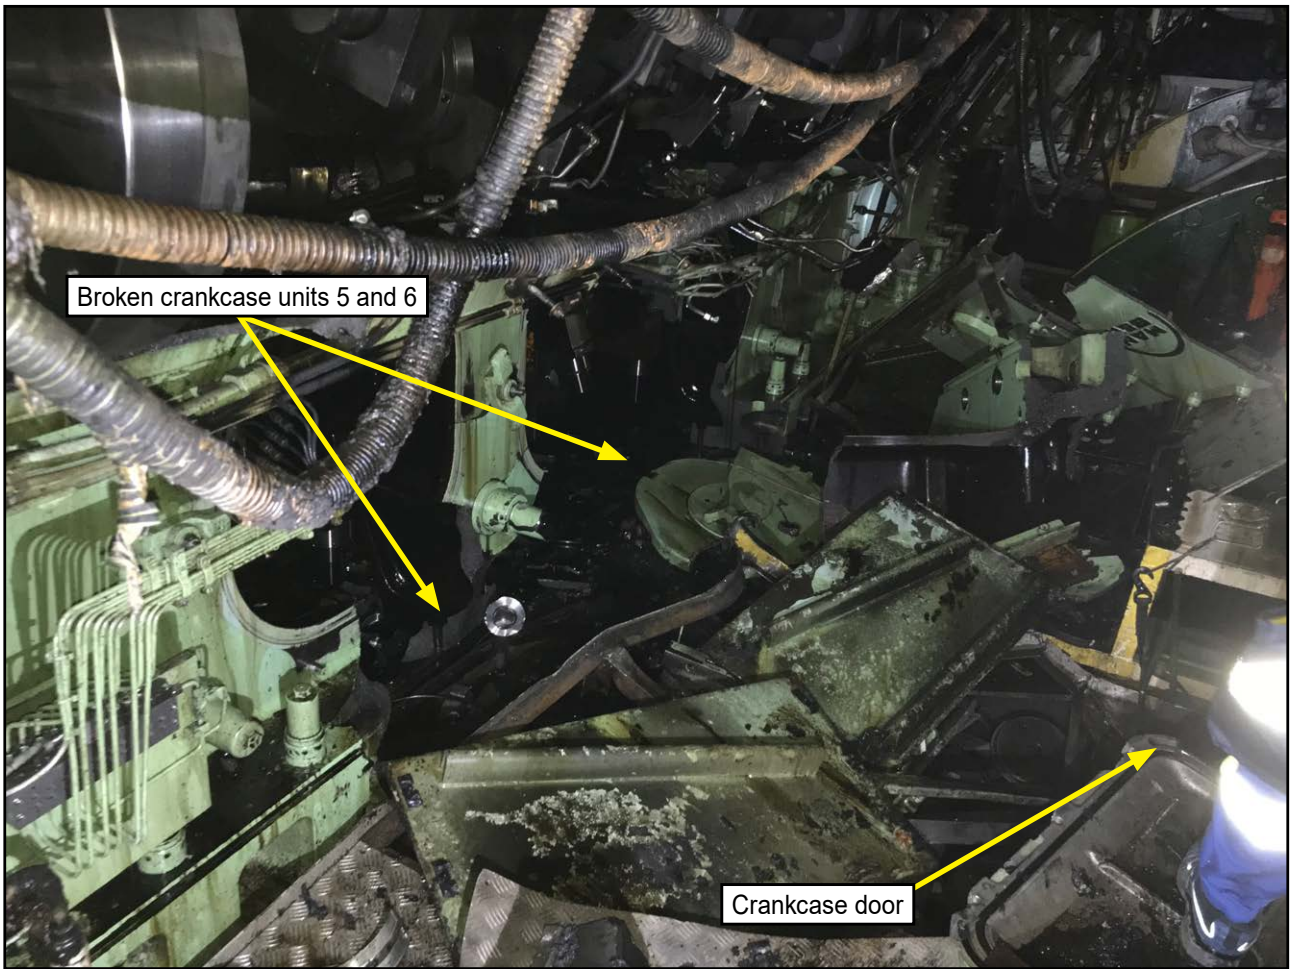
**Figure 17: Port side main engine**

*Finlandia Seaways'* main engine suffered substantial structural and component damage during its failure. The engine crankcase structure was ruptured on the port and starboard sides of units five and six, with crankcase explosion relief valve doors and large sections of the crankcase casting being propelled several metres across the floorplates (**Figures 17 and 18**).

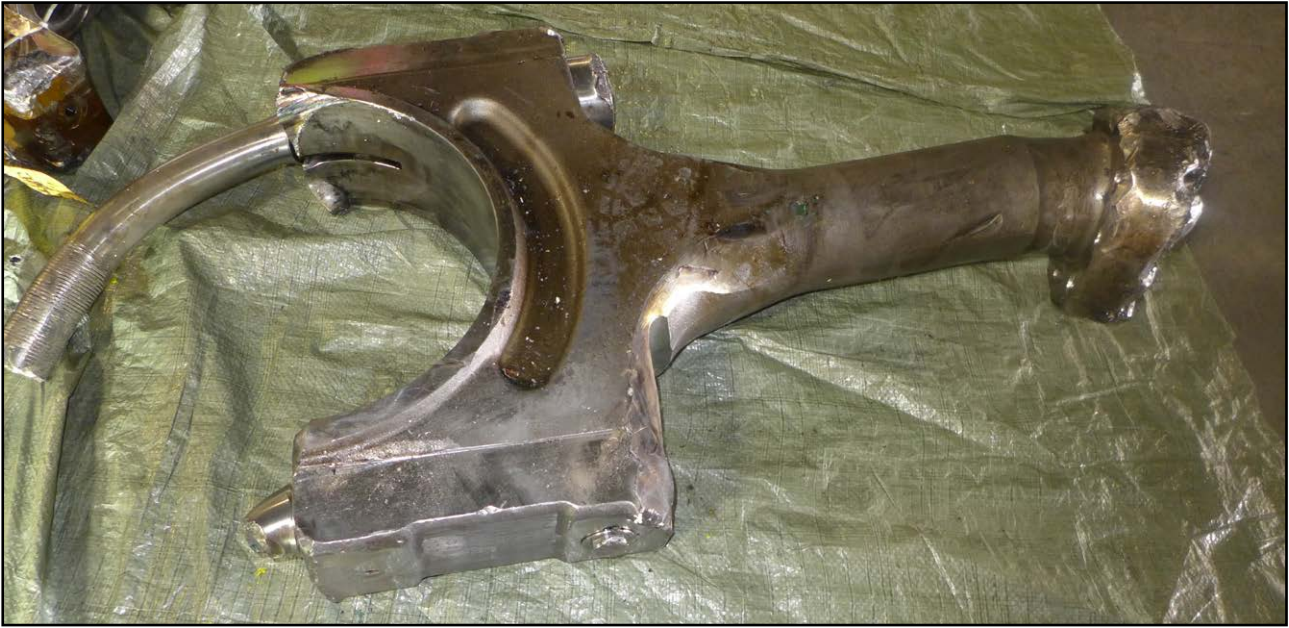
**Figure 19:** Section of A5 connecting rod (after removal from engine room)

A5's connecting rod (**Figure 19**), the lower half of its piston and its crankshaft counterweight had been ejected through the starboard side of the crankcase. The connecting rod had separated at its small end eye, shank flange and big end bolted connections. The big end bearing cap was found at the forward end of the engine room deck plates on the port side. B5's connecting rod and its piston had also been ejected from the crankcase and were found on the starboard deck plates (**Figure 20**), the connecting rod assembly having separated at its bolted shank flange. The broken upper half of A5's small end, and B5's big end lower half, were found in the engine room starboard bilge.

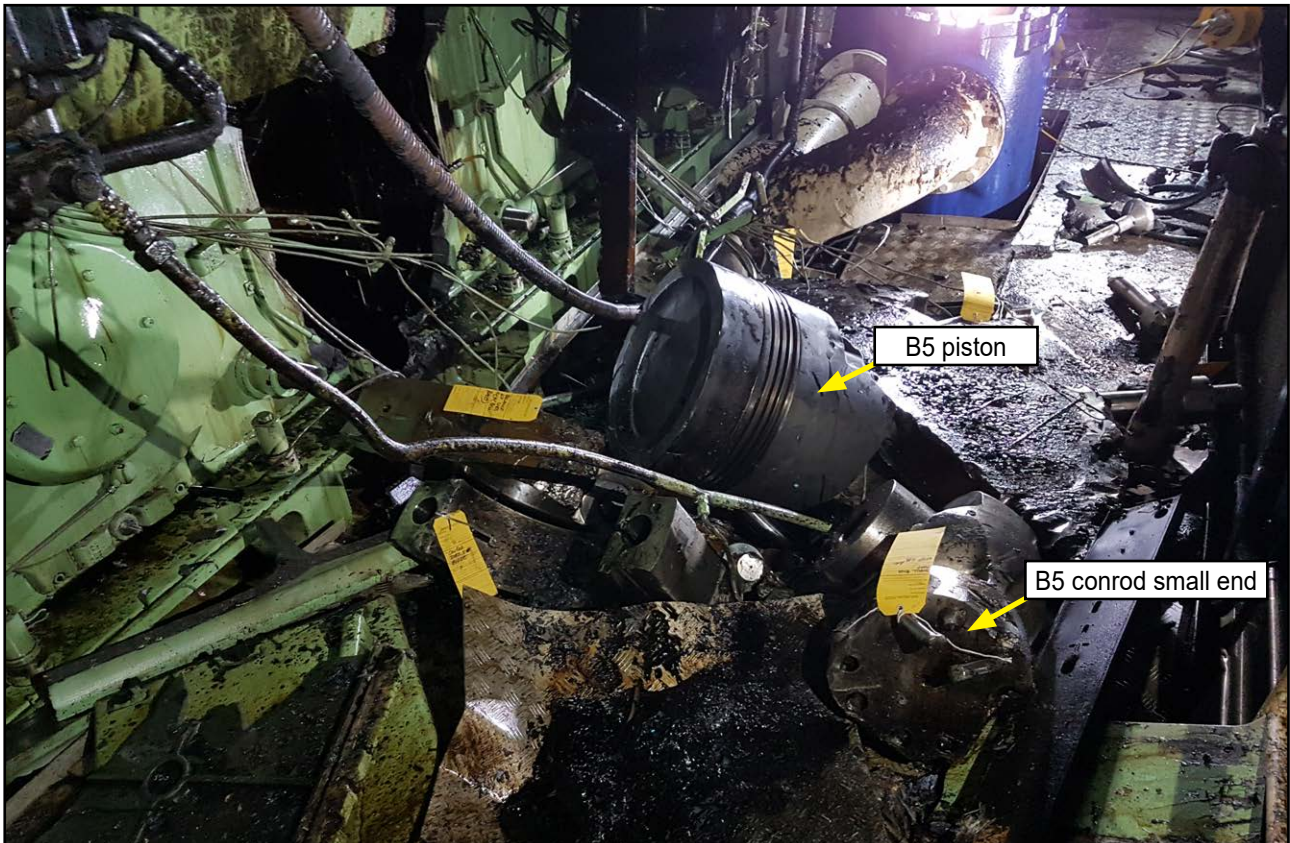
**Figure 20:** B5 components on starboard side deck plates

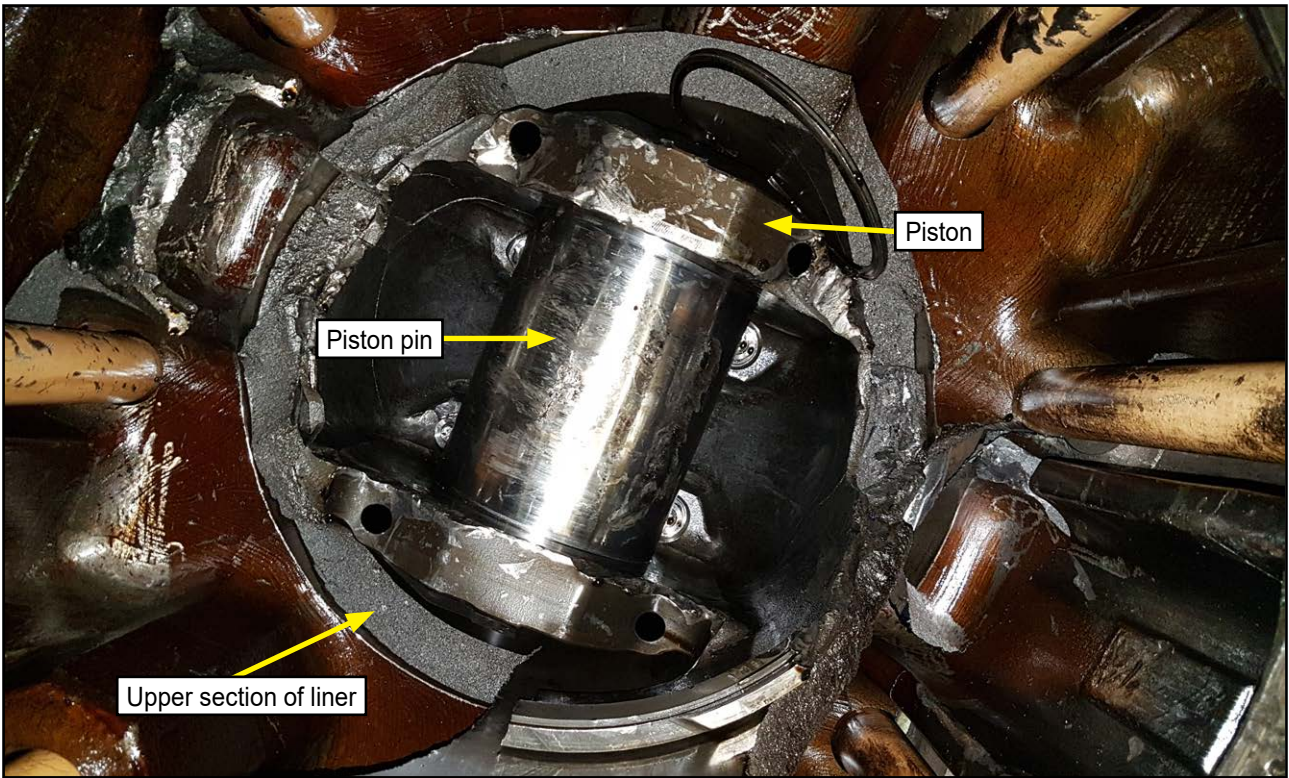
**Figure 21:** A5 cylinder viewed from engine sump

The upper part of A5's piston and its piston pin<sup>6</sup> remained in the upper section of the cylinder liner (**Figure 21**); the lower section of the cylinder liner had shattered and dropped into the sump. Although badly damaged at its lower end, B5 cylinder liner did not suffer the same level of damage as A5 (**Figure 22**). Impact damage had occurred to the crankshaft at number five crankpin journal and the crankpin webs. The camshaft covers for both banks had become detached and the A-bank camshaft had also been partially displaced.

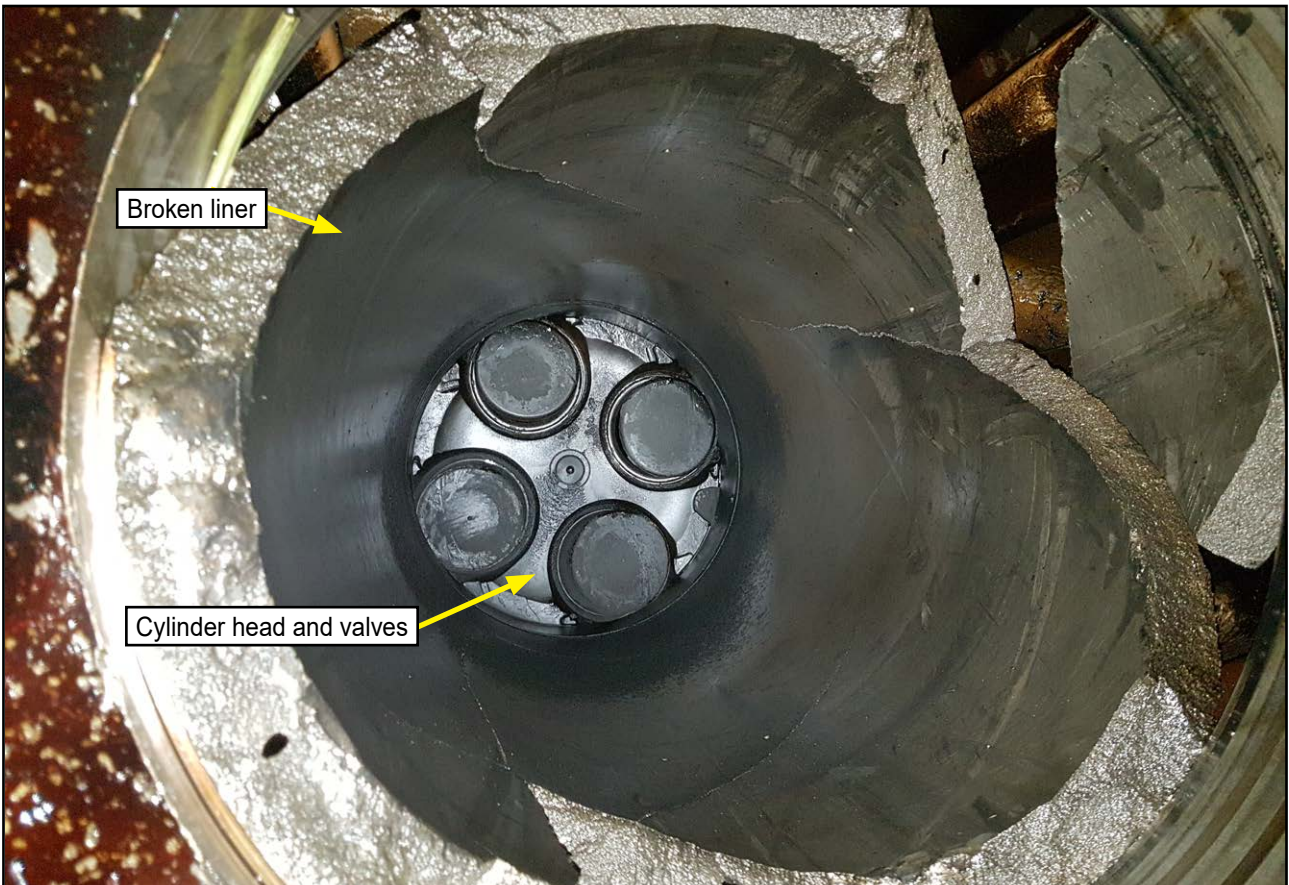
**Figure 22:** B5 liner (looking up to inlet/exhaust valves from engine sump)

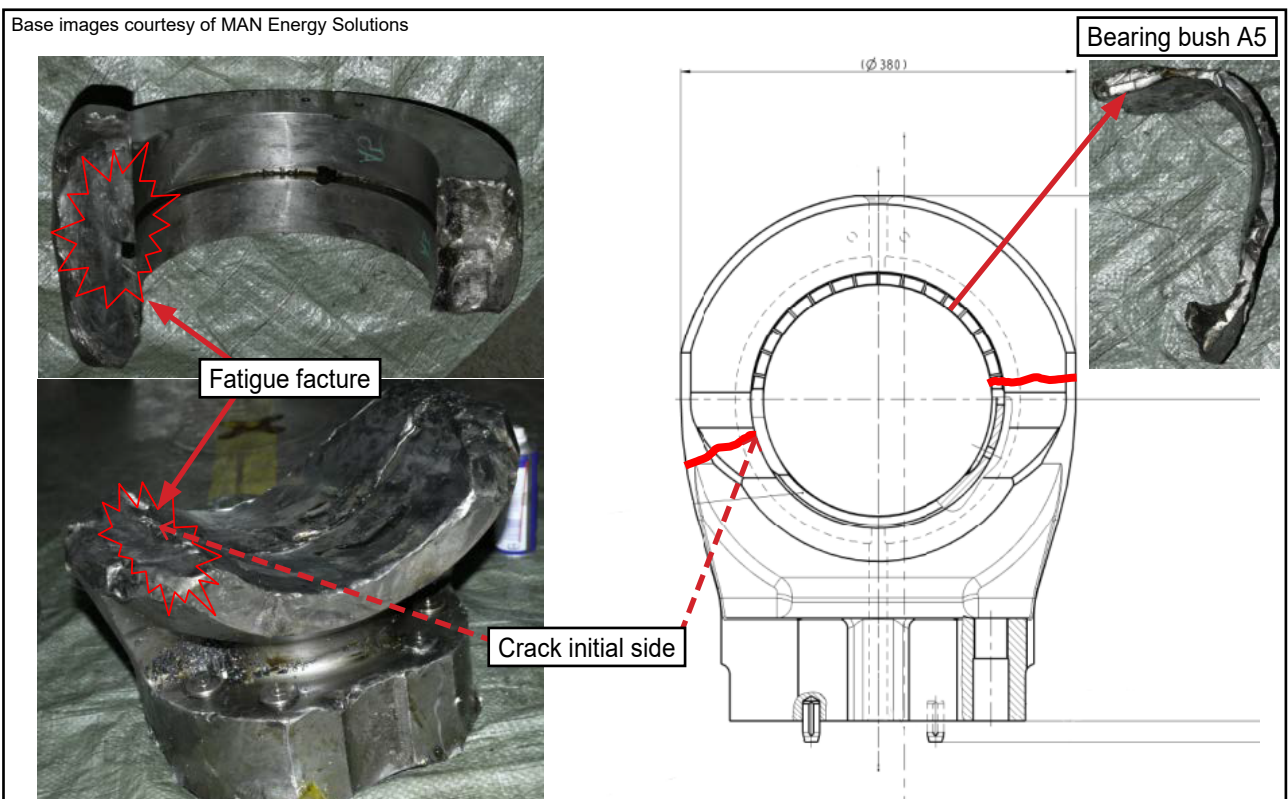
**Figure 25b:** A5 small end fatigue fracture

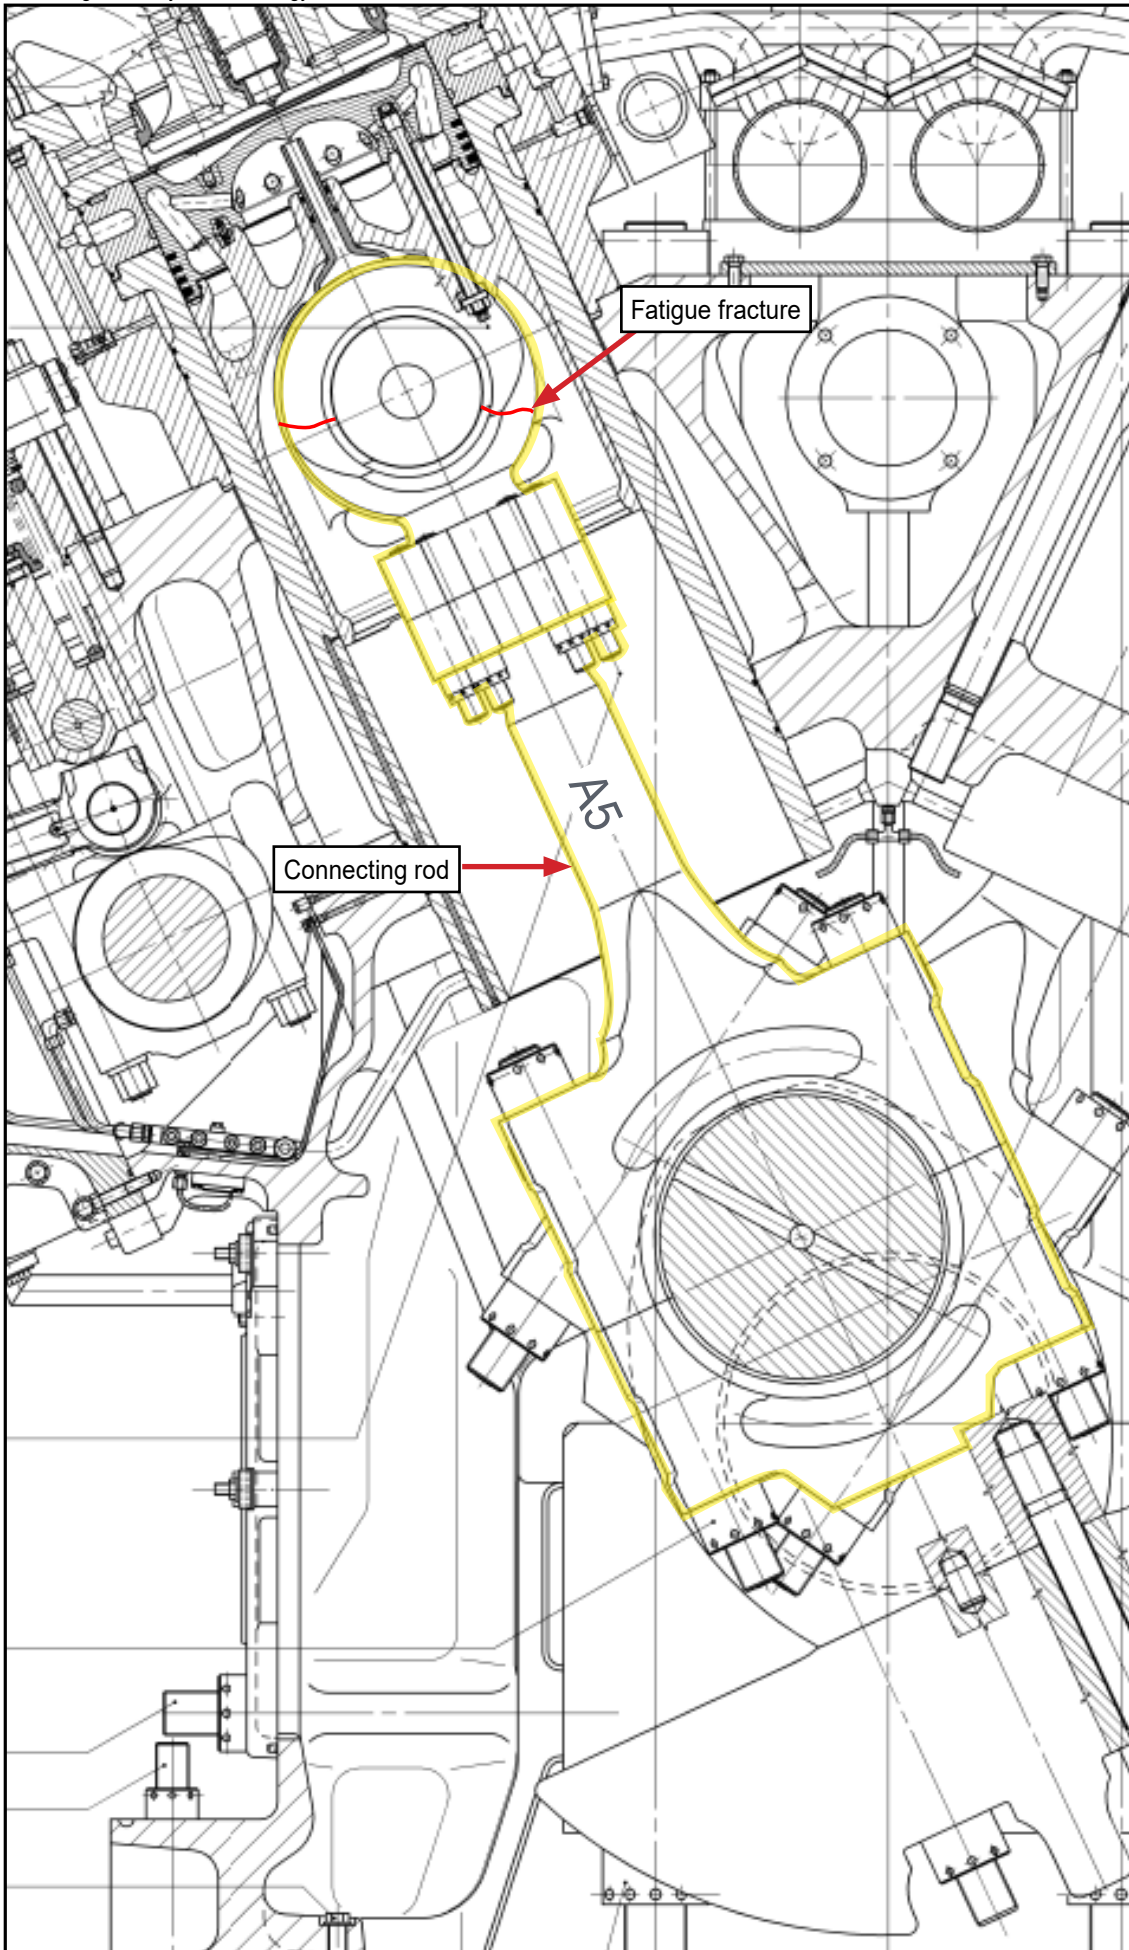
**Figure 25c:** A5 looking forward and fatigue fracture

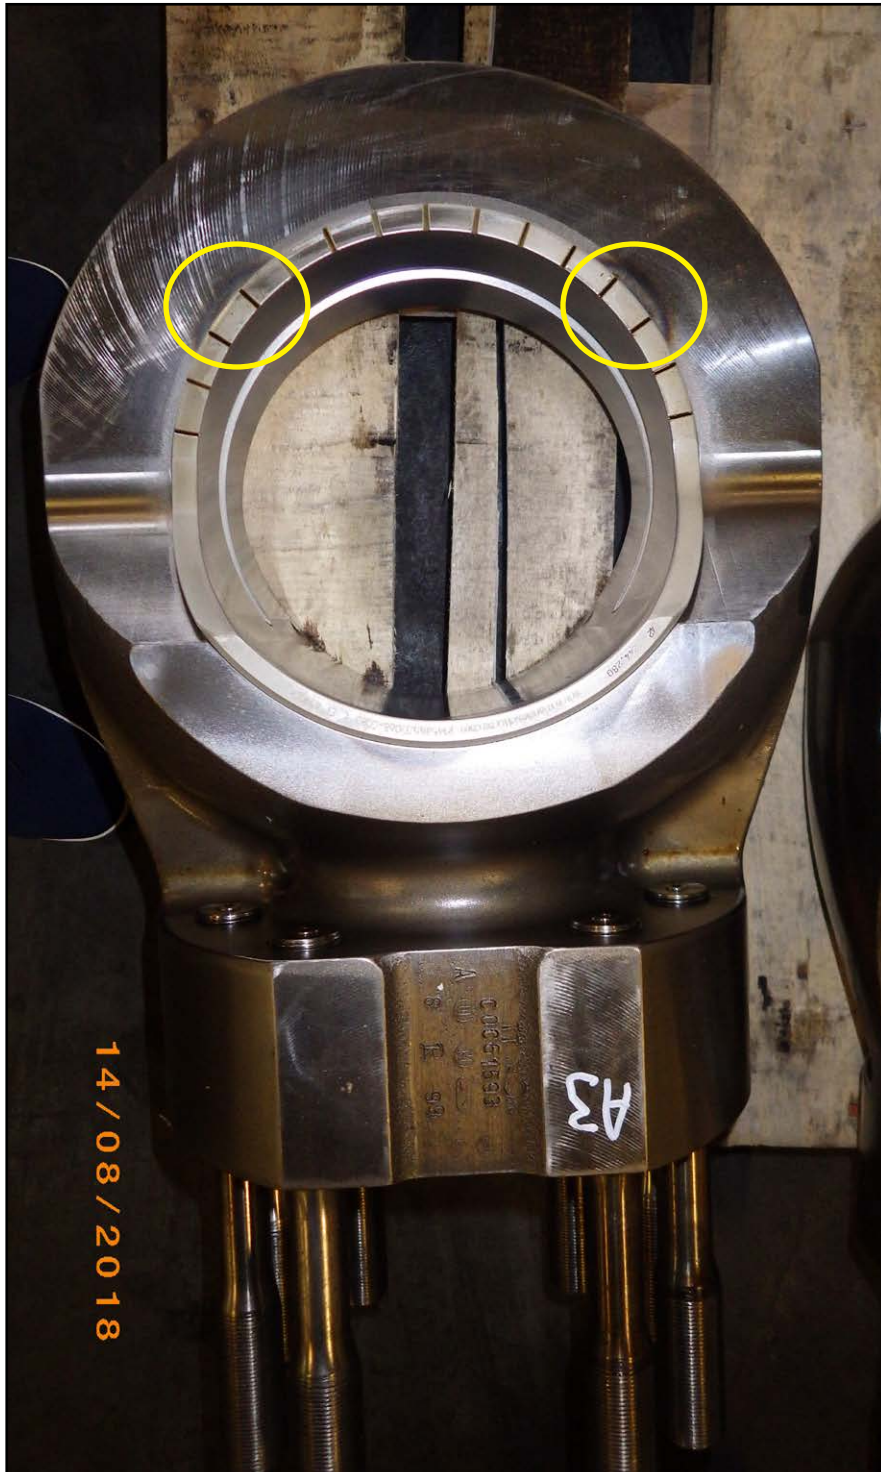
Between 6 and 25 August 2018, while out of service in Marseille, France, all of *Botnia Seaways*' main engine connecting rods were replaced. During the initial inspection of the small ends, the attending LR surveyor identified heat marks on the inner edge of one of the small ends (**Figure 27**). MAN specialists examined the marks and concluded that they were not caused during engine operation. MAN's assessment was that the localised heat marks had been caused by the application of intensive heat from something like a gas welding torch. MAN suggested that

**Figure 27:** *Botnia Seaways* small end heat damage (circled)

this had been to assist with the piston pin bush removal/installation process. MAN further concluded that the intense local heating would have produced an annealing<sup>12</sup> effect of the metal, resulting in structural changes affecting the material strength.
