## SAFETY INVESTIGATION REPORT

REPORT NO.: 01/2023

### **MV NEPTUNE THELISIS**

**Leaking thermal oil  
leading to an engine-room fire while underway  
in position 31° 16.8' N 029° 48.6' E  
17 January 2022**

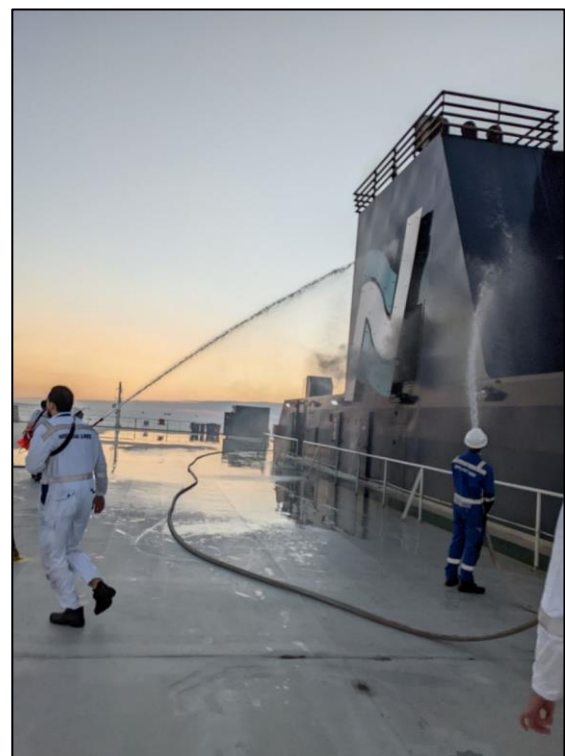
**Figure 3: Boundary cooling of the funnel casing from the upper weather deck**

With the fire-fighting operation in progress, the emergency generator was switched on at about 1700. Boundary cooling of the funnel casing was also initiated from deck no. 7 and the upper weather deck (no. 9), using the vessel's main and emergency fire pumps (**Figure 3**).

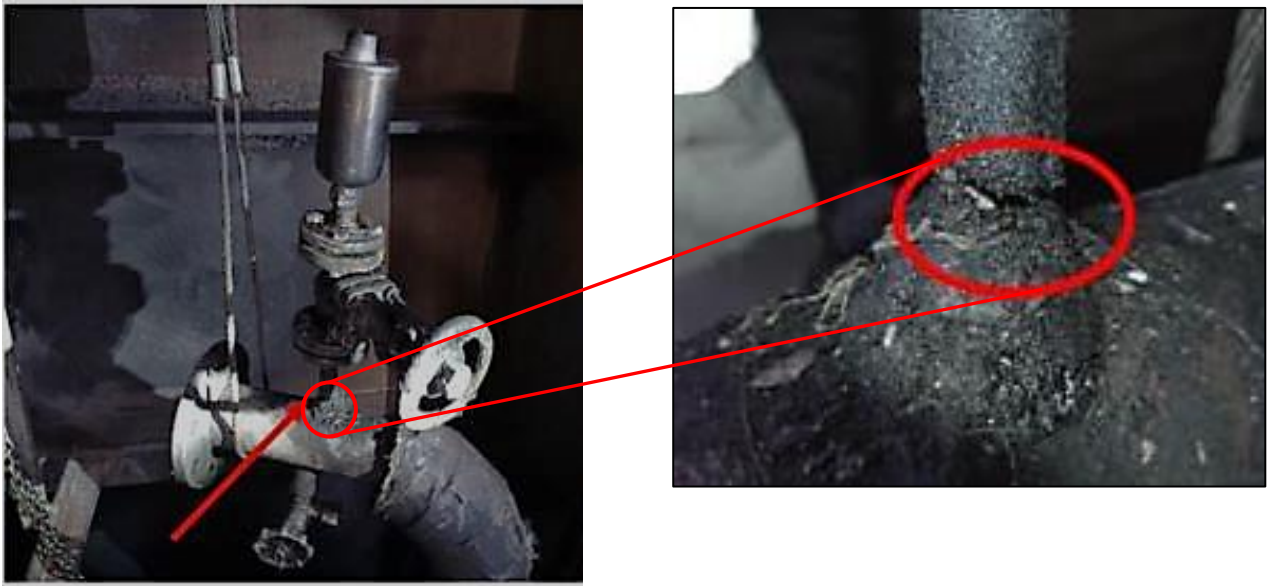
Figure 4: Crack at the weld seam

During their inspection on 19 January, crew members observed a crack in way of an air vent, fitted on the inlet thermal oil piping (**Figure 4**). The crack on the weld seam was also confirmed by the attending class surveyor.

Examination of the pipe clearly showed a relatively large amount of weld material. Cracking was very apparent around the transition between the weld and the pipe material (also known as toe cracking). Furthermore, the polished cross section of the sample showed very large internal pores/blow holes inside the weld material build up (**Figure 6**).

1. Leaking thermal oil came in contact with a hot surface on the economiser
2. The examination of the sample showed an array of welding defects ranging from gross and excessive weld material build-up (necessarily generating large thermal stresses), distributed unevenly around the pipe circumference, and creating visible fillet distortion, to large undercutting at the pipe toe end of the fillet.

3. The cross section of the failed pipe also showed that the poor tie-in into the base metal caused a local reduction in the pipe wall, further weakening the vent tube.

4. The undercut served as a highly effective stress intensity site for crack initiation, with the pipe bending into the undercut region and allowing progression of the crack front into the inside of the tube.

5. Mechanical stress, either through vibration of the assembly, or by pressure variation inside the tube and / or residual thermal stresses, could have caused any number of these features, leading to premature failure.

6. Previous damage to the pipe may have been repaired, using inadequate welding techniques.
7. While specifically undercutting is a defect typically associated with improper welding parameters, the range and extent of defects present in this small section of weld may have been compounded on site, where access to proper surface preparation (before and in between runs) and positioning around the pipe was limited, as was the case for any subsequent weld inspection.

A new vent pipe was manufactured by a DNV approved welding shop and fitted in place, followed by the necessary non-destructive testing (NDTs) and pressure testing. The thickness of different areas of the system was measured to ascertain that it was still within the approved criteria. Additional supports were also manufactured and installed to minimise vibration as much as possible.

- additional supports have been fitted in the new air vent pipe to minimise vibrations and possible cracks, to the satisfaction to the attending class surveyor;
- the Company's internal investigation report has been circulated to all vessels in the fleet.

**01/2023\_R1** Communicate the findings of this safety investigation report to the fleet under its management, to highlight the issues related to poor welding techniques.

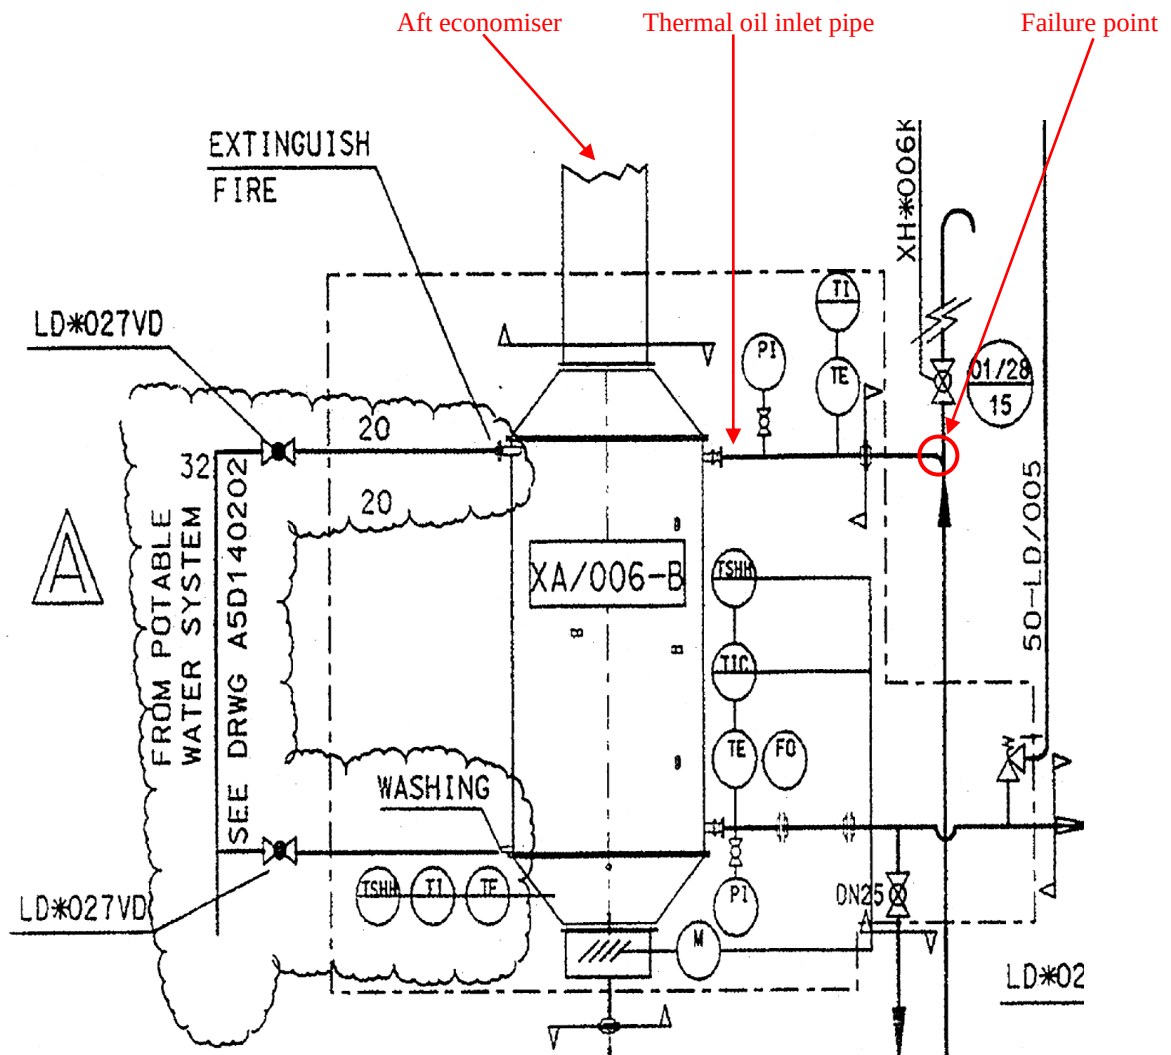
Figure 5: Part of the schematic drawing, showing the failure point

**Figure 5** shows part of the main schematic drawing, indicating the failure point, in relation to the system.

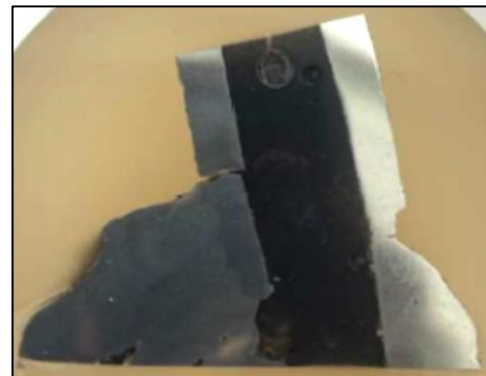
**Figure 7: Polished longitudinal transverse section**

The section also showed weld undercutting with extensive cracking across the entire pipe wall thickness, visible in **Figure 7**. It appeared that the crack propagated from the undercut to the inner tube with the front on one side of the pipe reaching full depth while still progressing at the opposite end.

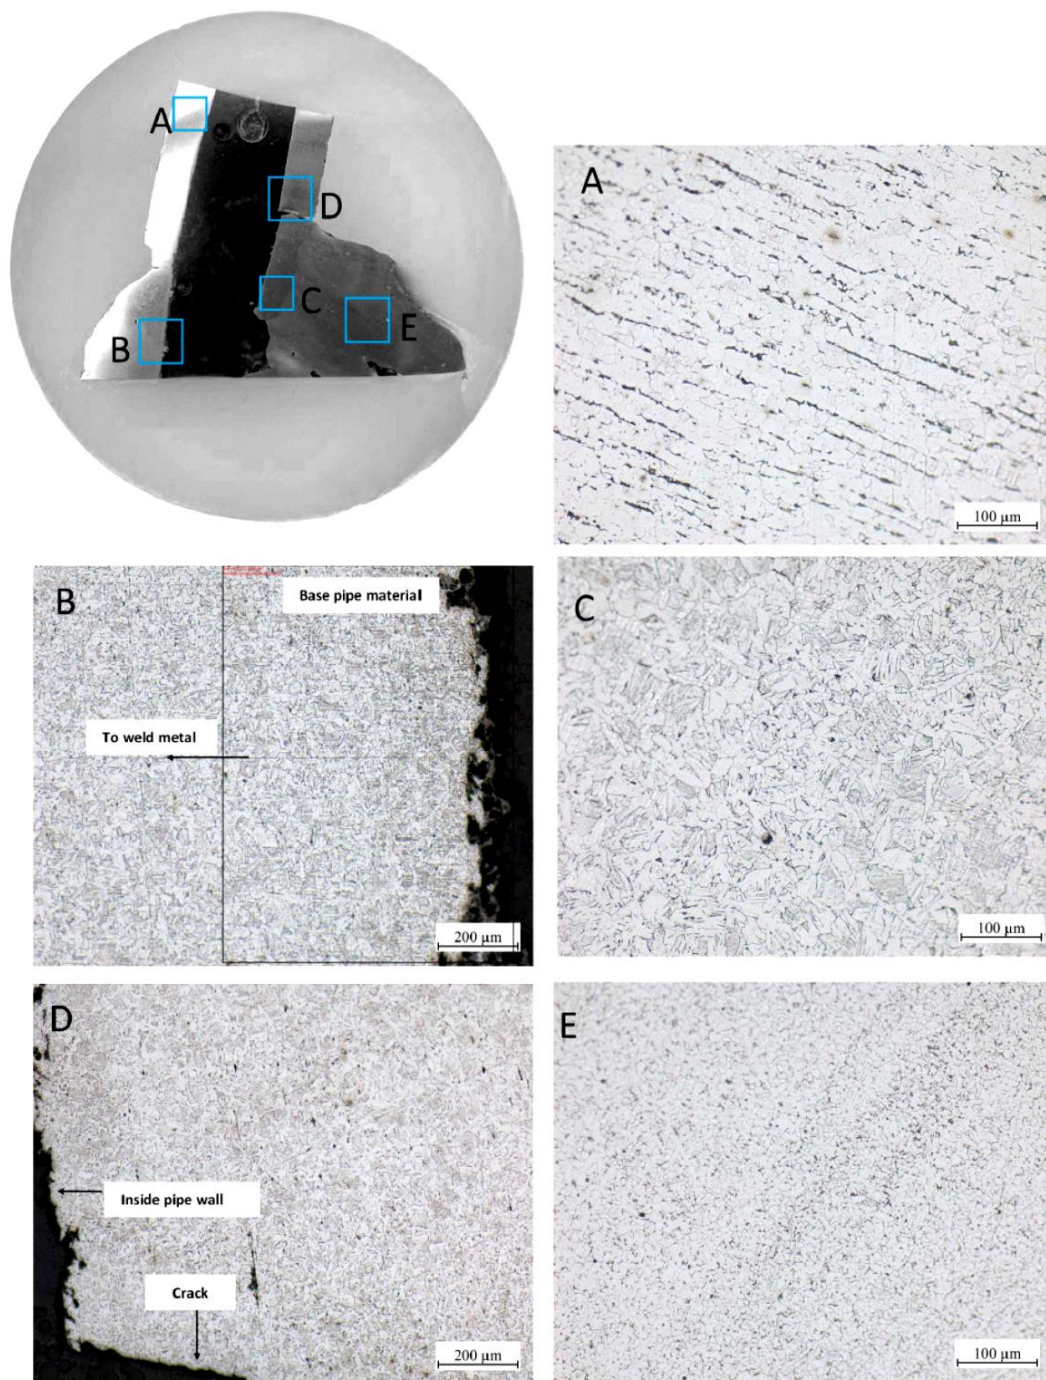
**Figure 8: Optical micrographs of various sites across the pipe and weld material section**

**Figure 8** shows higher magnification images of the longitudinal section of the pipe, following etching in Nital. Comparison of the resultant microstructures across the near-weld region and pipe metal further away from the weld, showed significant differences, indicative of recrystallisation and grain growth. This was also correlated to Vickers microhardness measurements (HV200) at the region corresponding to the

heat affect zone, which showed a hardness reduction of approximately 15% to 135.9HV200. However, it should be stated that these metallurgical and resultant mechanical property changes are considered within the norm.

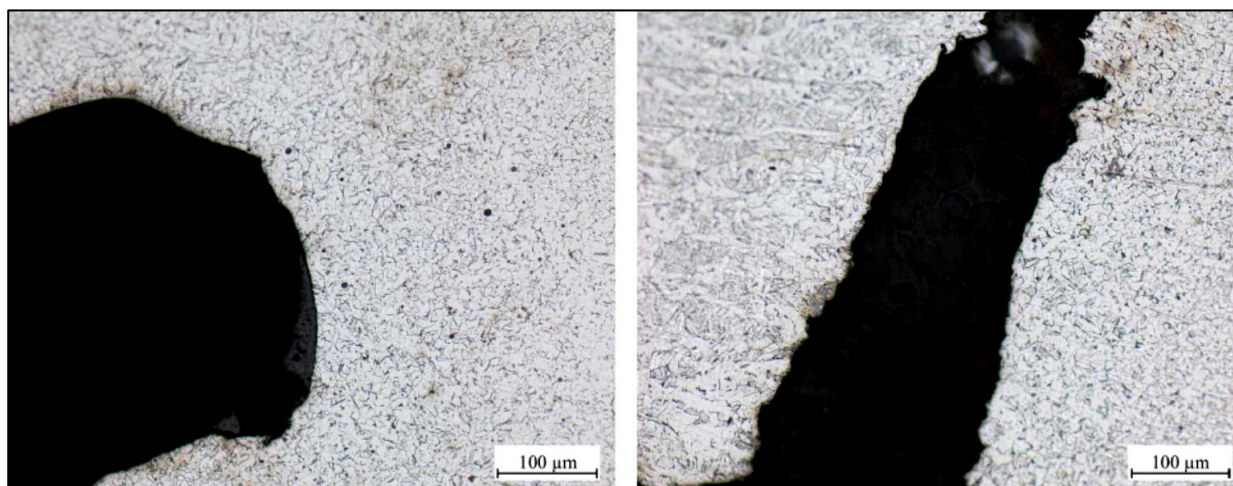
**Figure 9: Optical micrographs of material around the crack fronts**

Finally, a closer inspection of the crack and its front showed no sign of corrosion damage or stress corrosion (**Figure 9**).
