### BLUE CECIL MARINE SAFETY INVESTIGATION REPORT

Multiple Fatalities During Enclosed Space Entry

South China Sea | 8 December 2023

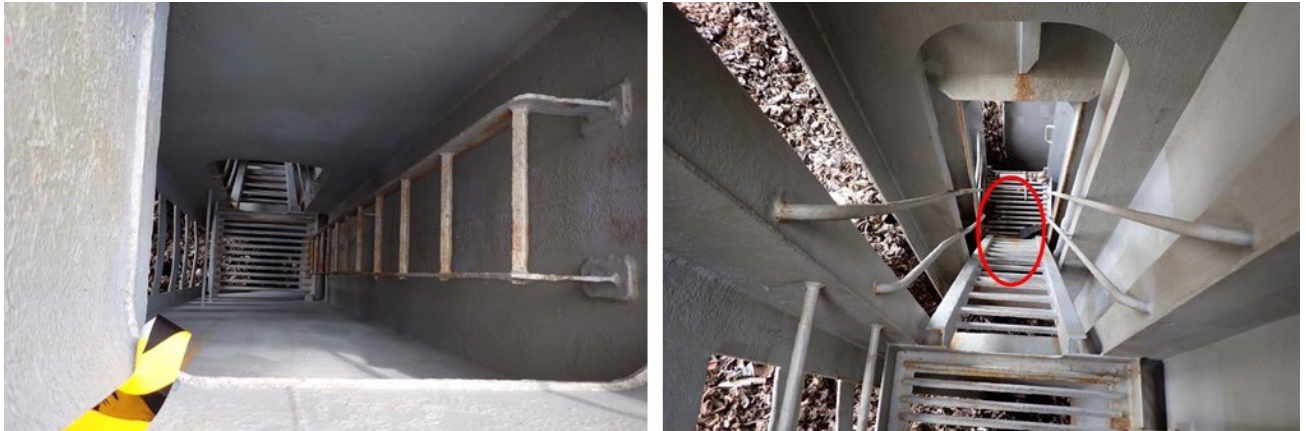
Both gas detectors activated when the C/O checked the atmosphere inside the booby hatch. The C/O directed the Bosun to fully open the hatch covers for Cargo Hold No. 1 and then directed the two ASDs who had donned SCBAs to enter the cargo hold through the booby hatch. By 1747, the two ASDs had located the C/E, ETO, and Fitter lying unconscious at the bottom of the inclined section of the Cargo Hold No. 1 aft access ladder (see Figure 2).

Figure 2: Cargo Hold No. 1 aft access ladder. The vertical ladder leading from the booby hatch to the upper platform is shown in the photograph on the left. The inclined ladder between the upper and intermediate platforms is shown in the photograph on the right. The location where the C/E, ETO, and Fitter were found at the bottom of the ladder and on the intermediate platform is circled in red. The cargo of scrap metal is visible in both photographs.

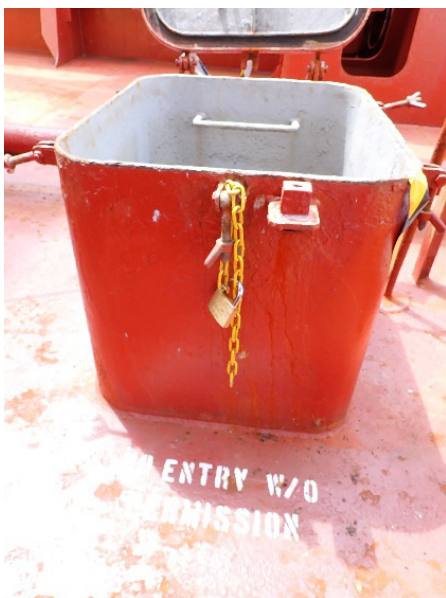
Each of the booby hatches for all five of BLUE CECIL's cargo holds were marked "NO ENTRY W/O PERMISSION" (see Figure 3).<sup>10</sup> The top of each booby hatch cover was also marked "RESTRICTED AREA." Crewmembers stated the warnings had faded and had been repainted after 8 December 2023. It was not reported why the warning differed from the warning required by the Company's cargo hold access procedures. Each of the booby hatches had also been fitted with a lock after 8 December 2023.<sup>11</sup>

Figure 3: Aft booby hatch for Cargo Hold No. 1.

1. It is recommended that the Company:
  - (a) review and, as necessary, revise its enclosed space entry procedures to:
    - (i) document the requirement for cargo hold bobby hatches to be locked and that the keys be held by the ship's C/O; and
    - (ii) require that before an Enclosed Space Entry Permit is closed that the relevant space be checked to ensure that no tools or equipment are left behind;
  - (b) review and, as necessary, revise the Company's Stop-Work Process to address the actions a crewmember initiating a stop-work action should take if crewmembers to whom a stop-work action is addressed do not acknowledge the action, stop the work that was being done, or assess the situation to determine if some corrective action was required before restarting work;

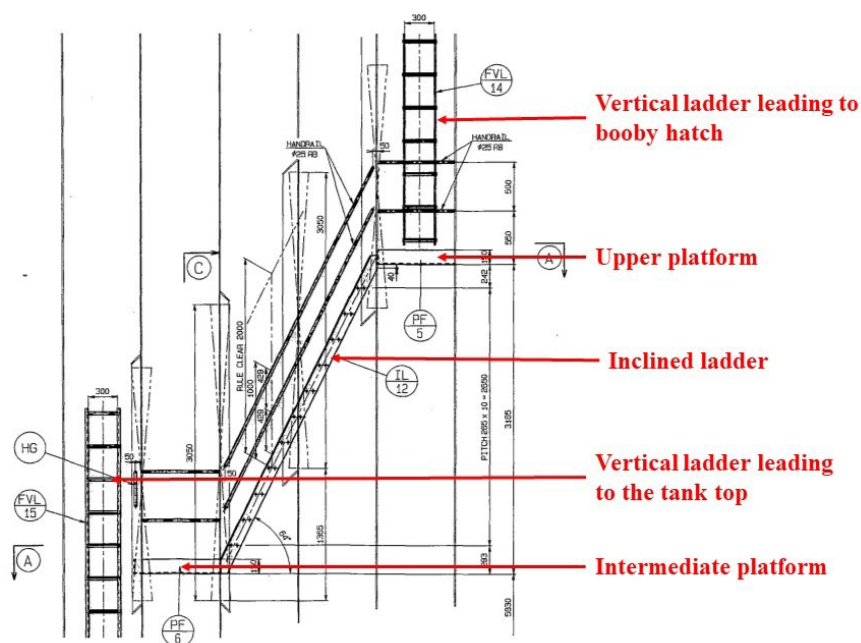
The aft access ladder for Cargo Hold No. 1 consisted of two vertical ladders, an inclined ladder, and two platforms (see Figures 2 and 4).<sup>12</sup> The aft access ladder for Cargo Hold No. 1 was found in good condition and free of defects.

Figure 4: Detail of Cargo Hold No. 1 aft access ladder.
