## SAFETY INVESTIGATION REPORT

REPORT NO.: 02/2025

### **MT Chemical Hunter** **Fatal injuries to a crew member in the ballast pump-room,** **in position 22° 42' N 097° 11' W** **on 28 January 2024**

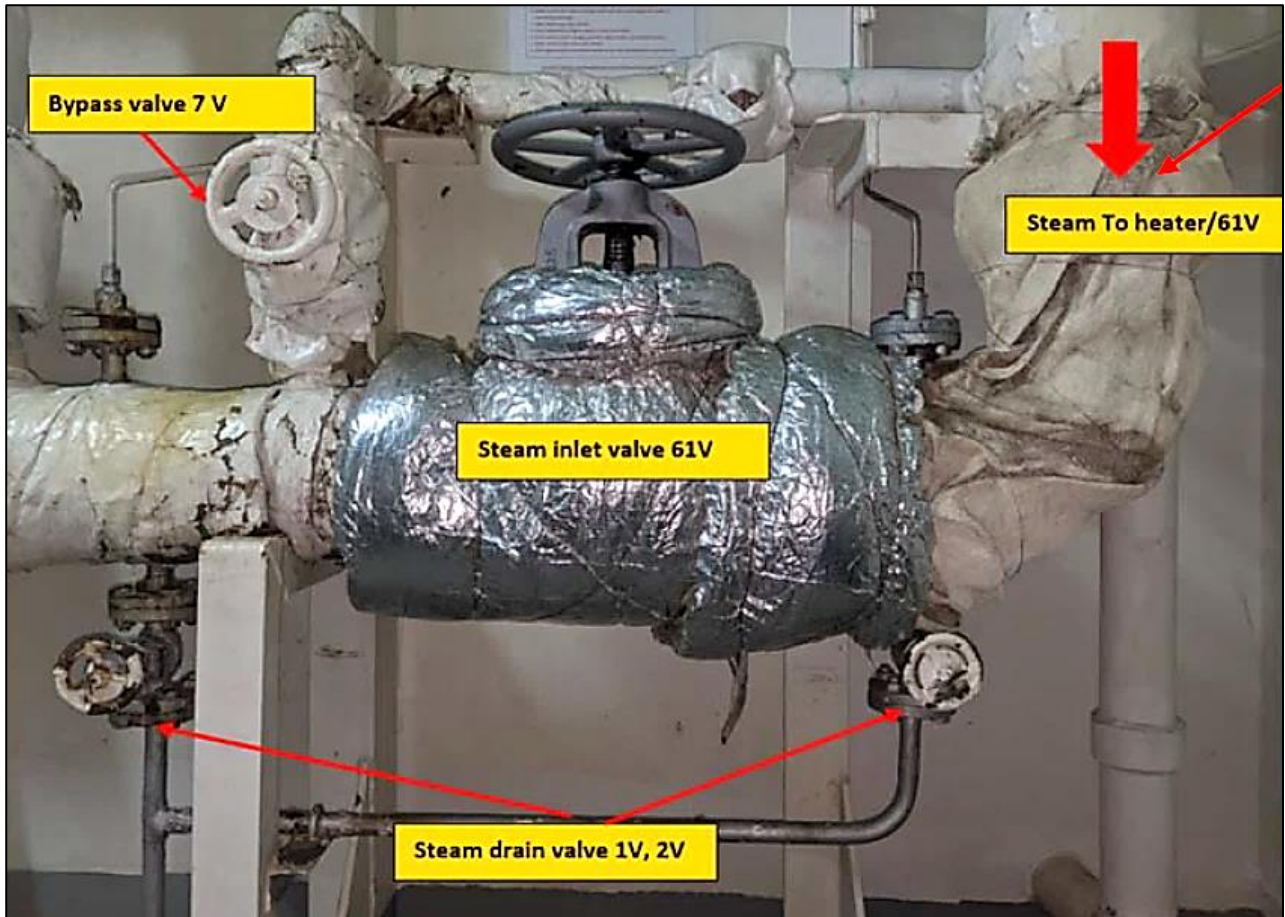
**Figure 1: Steam inlet line**

At 1216, the AB entered the ballast pump-room, following the instructions from the chief mate to line up the steam line to the water heater (**Figure 1**). The chief mate asked the duty engineer to reduce the steam to 50% as the cargo tanks live steaming was being concluded.

The steam inlet line had two drain valves, one before and one after the valve. A smaller diameter bypass line was fitted for preheating

the water heater (**Figure 1**). The ruptured steam inlet valve was a globe valve of cast steel construction, with a nominal diameter of 125 mm and working pressure of 10 kPa.

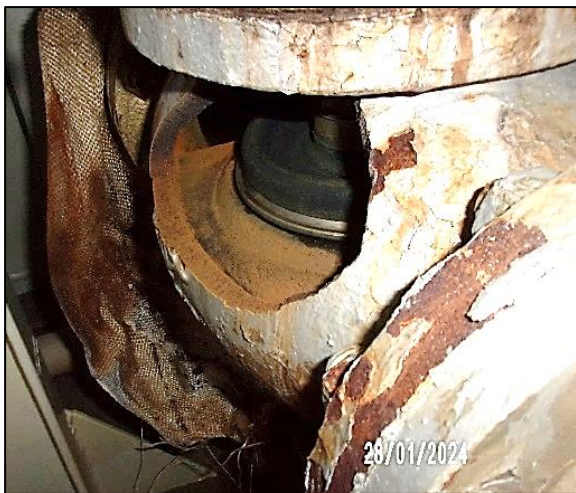
**Figure 2: Ruptured steam inlet valve**

The safety investigation received conflicting information as to the amount by which the cargo tank cleaning water heater steam inlet valve was found open, varying from being cracked open to one turn open (**Figure 2**). There was also conflicting information regarding the entry time of the AB into the pump-room<sup>2</sup>.

At about 1305, the chief mate, along with the pumpman, entered the ballast pump-room and established that the escape of live steam was the result of the steam inlet valve, which had ruptured (**Figure 2**).

The metallurgical examination conducted on the failed valve body and fragments concluded that the mechanism of failure was most likely to have been fatigue. The steam valve exhibited signs of corrosion and delamination of the protective paint. The examination revealed signs of pre-existing multiple developing cracks on the body (**Figures 7 and 8**). Although the material composition of the valve body was within specification, there was a wide variation of wall thickness (up to 7 mm) in the valve

The metallurgical analysis concluded that the failure mechanism was fatigue. The cyclic loading required for fatigue failure was thermal in the case of the steam valve because of the heating and cooling of the valve during the periods when the tank cleaning heater was used.

**Figure 2** revealed heavy rust stains on the inside of the valve lagging. This further corroborated the metallurgist's findings. The valve casing had most probably developed cracks over time, and steam and water were seeping through. The delaminating protective paint was also further evidence of pre-existing cracks.

**02/2025\_R1** – examine all steam valves and mountings in their fleet, using NDT techniques, if necessary, to verify their integrity.

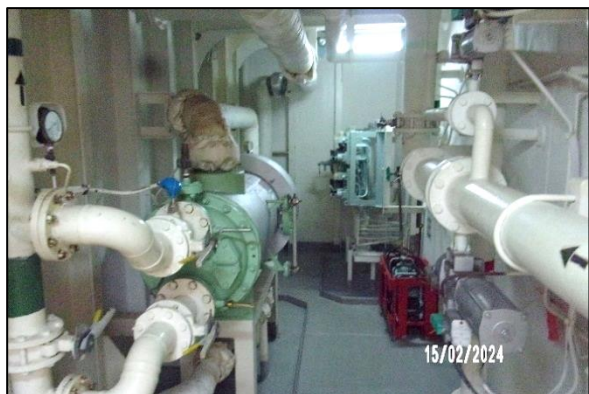
**Figure 3: View of heater when entering**

The cargo tank cleaning water heater was located at the far end of the ballast pump-room (**Figure 3**). The heater was a U-tube stack, with seawater passing through the coils and steam around it in its shell. Steam was generated by an oil-fired vertical water tube boiler, with a working pressure between 6 bars to 8 bars, and an evaporation rate of 15,000 kg $\text{hr}^{-1}$  at 7 bars.

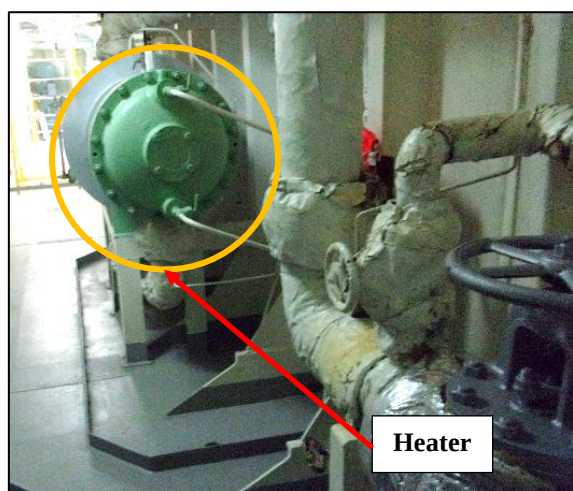
**Figure 4: View of the heater looking outside**

The heater (**Figure 4**) was capable of heating about 100 m $^3\text{hr}^{-1}$  of wash water from about 20 °C to 80 °C. This allowed simultaneous operation of six tank washing machines.

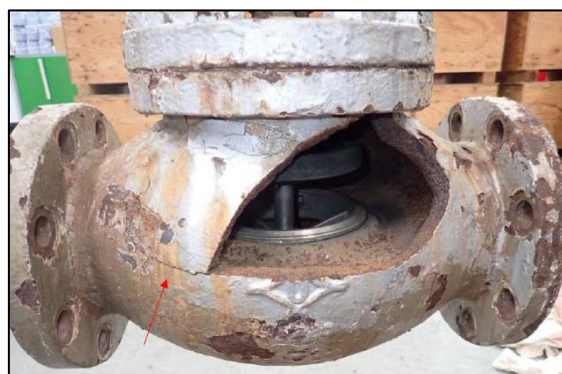
**Figure 7: Continuing crack with further existing cracks bifurcating from it**

In addition to the cracked surface, crack fronts progressing through the valve casing were observed. This suggested that more than one crack front was growing progressively with time and therefore, a single rapid failure event was less likely. This was congruent with the fact that slow cracks can develop segmented crack fronts, each segment subsequently propagating along separate fracture planes.

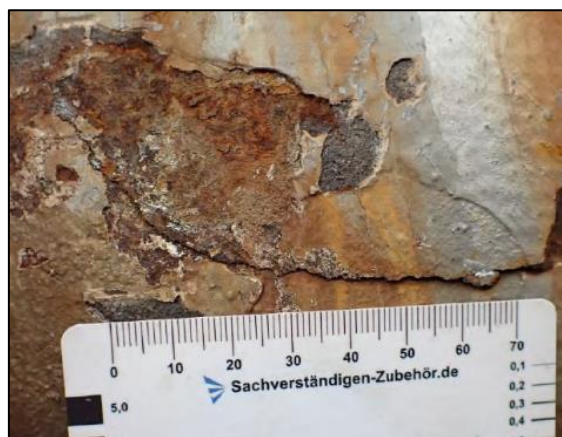
The detached fragment from the valve casing was examined under a microscope at 10 arbitrary, but evenly spaced locations. Despite cleaning with a de-rusting agent, it was observed that some of the rust adhered more tenaciously to the fracture surface, suggesting that the rusting was of a longer standing nature and therefore, the failure was progressive instead of instantaneous.

**Figure 8: Close up of crack**
