# **IMCA eCMID System Annual Report 2024/25 – Inspection Findings & Quality Assurance**

**IMCA M270  
July 2025**

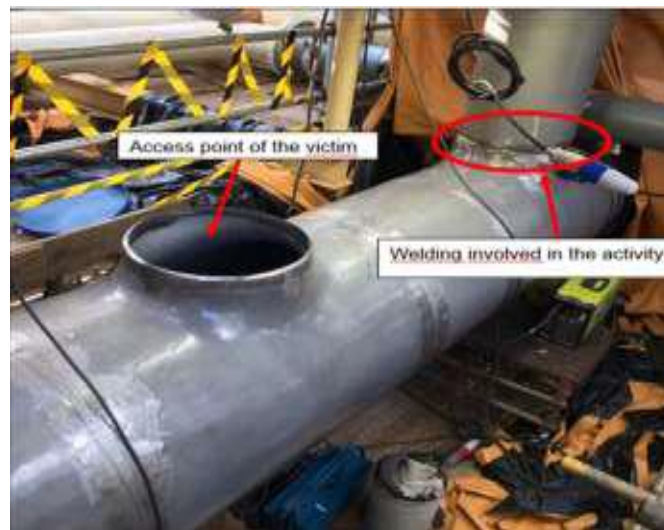
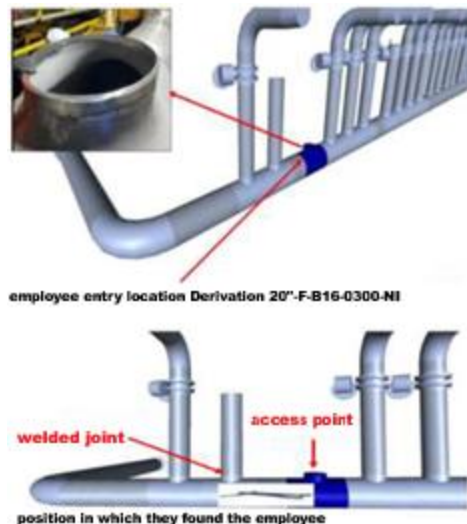
Late last year, an incident was brought to IMCA’s attention relating to a confined space entry hot work fatality in a shipyard. A welder entered an 86cm (34”) pipe through a 50cm (20”) opening to check on welding being carried out. He was found unconscious by another worker who had noticed his absence and called the emergency team. First aid was provided by the shipyard rescue teams, and he was then taken to a local hospital, where, though care was continued, he was sadly pronounced dead.

- ◆ There was a failure of leadership – inadequate supervision.
- ◆ There was a failure in planning and risk assessment – whilst the Permit to Work was comprehensive for all welding activities at the site, it did not address or warn about the specific risk of inert gas (argon) related to the task being performed.

- ◆ Motivation: There was a lack of clarity in the criteria for evaluating welders' performance, which generated doubts about possible consequences due to failed welding. In addition, though the welders had been told not to enter the pipe, they were not fully made aware as to why this was: conditions inside the pipe were not known by the welders.

- ◆ Procedures were inadequate: The welding procedure did not clearly address the welders' performance criteria, nor did it address the specific risks associated with the use of inert gas.

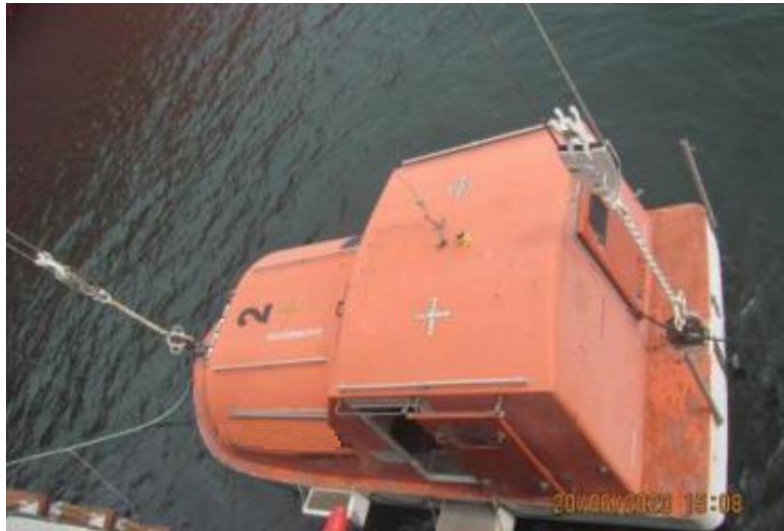
He let go of the ladder immediately for fear of getting his hands caught between the sliding ladder and the hull and fell about 2m directly onto the lifeboat.

*Lifeboat*

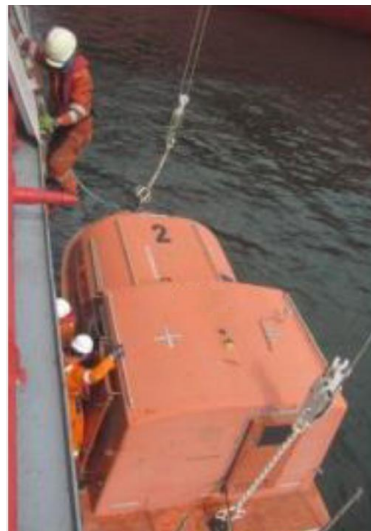
*Person climbing down Pilot Ladder*

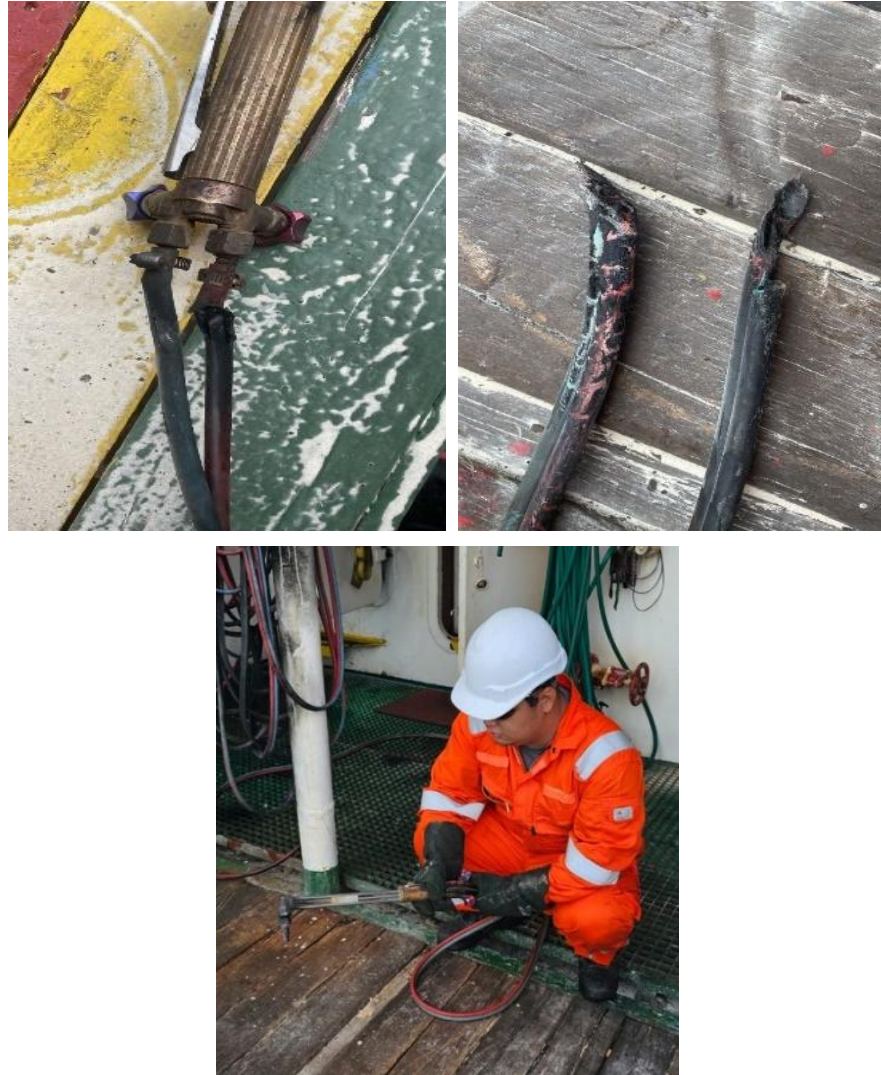
There was a small explosion and fire when crew were working on an oxy-acetylene system. Two engineers were setting up a new oxygen and acetylene cylinder for testing. They installed a flash arrestor and hoses on the cylinder, ensuring they were free from oil and grease. One of the engineers opened the nozzles of the oxy-acetylene bottle, igniting flames at the nozzle tip. A small explosion occurred, followed by flames from the acetylene hose connection on the torch. The hoses burst within seconds, causing that worker to get burnt. The other engineer pulled the injured person to safety. The fire was extinguished using a dry powder fire extinguisher. The injured engineer suffered first-degree burns.

- ◆ The oxygen/acetylene torch was not equipped with adequate flame or flashback arrestors.
- ◆ There had been excessive bending of the hoses which had led to a compromised flow of gas and increased risk of rupture under pressure.
- ◆ There was faulty equipment: The hose crimps on the cutting valve (acetylene) were faulty which led to the flashback occurring.

*Showing equipment damaged (re-enactment)*

- ◆ Fit flash arrestor to both the oxygen & acetylene gas hoses near to the regulators, for length hose, fit arrestor on both the torch and regulator.
- ◆ The fitting of a flashback arrestor is not a substitute for safe working practices. After a flashback, carefully check for damage to the torch, hoses, regulators, flashback arrestor and other components, if found faulty replace the parts.

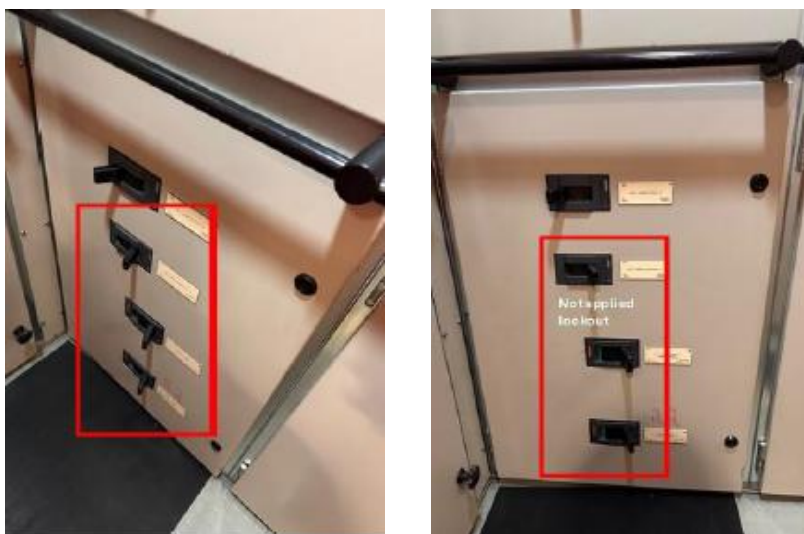
*Case 1: No LOTO applied on the main electrical switchboard*

- ◆ *Case 1:* Lock Out/Tag Out (LOTO) was not applied on the electrical switchboard by ETO during repair of AHT hydraulic pipeline. Though the main switchboard was switched off and emergency release button was activated from the bridge.

- ◆ LOTO should be fully implemented for all maintenance tasks – every maintenance or repair activity involving hazardous energy should follow a thorough LOTO procedure, regardless of the presence of physical barriers like switch-offs or valve closures. The absence of LOTO devices or failure to apply them properly can lead to severe injuries, equipment damage, or even fatalities.

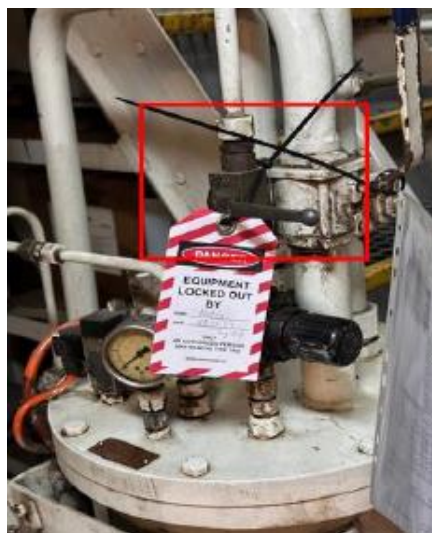
During a walkaround audit of a vessel engine room, problems were observed with the Lock Out/Tag Out (LOTO) process. It was observed that electrical equipment was switched off, but LOTO was not applied in place. Also, for the mechanical isolation, the locking device was not in place, though the mechanical valve was closed and tagged out.

*Case 2: No mechanical valve lock out was applied on the equipment*

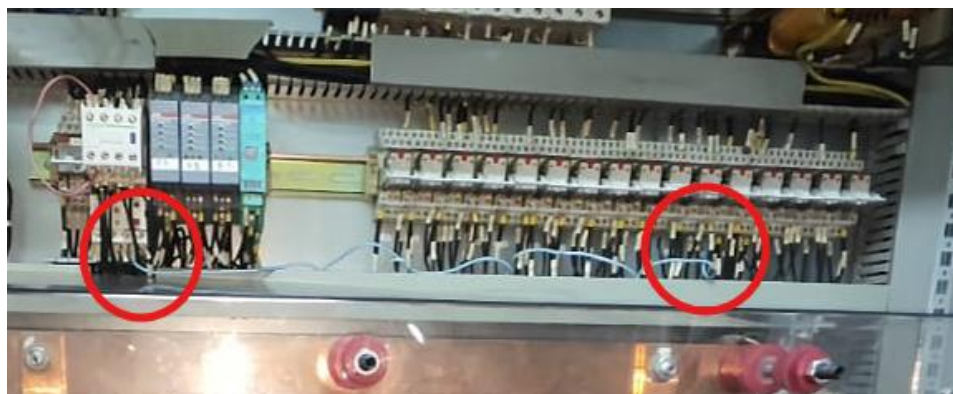
- ◆ Unauthorised and undocumented disconnections and bypassing of critical electrical systems were observed (see following page)). Such actions pose significant safety risks and can compromise the integrity of onboard operations.
- ◆ Improper reconnections may lead to major equipment damage, including short circuits, power fluctuations, or failures in essential onboard systems.
- ◆ Unauthorised disconnections or bypassing of critical electrical systems can expose personnel to serious electrocution hazards, especially if they unknowingly interact with live circuits.

*Unauthorised bypassing*

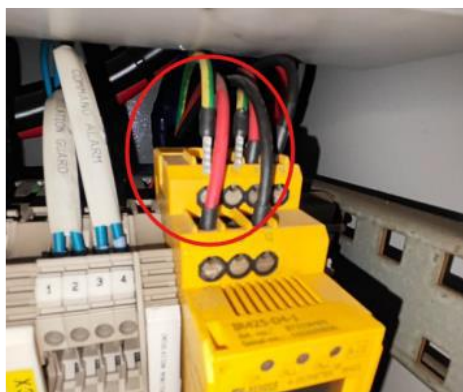
*Unauthorised disconnection*

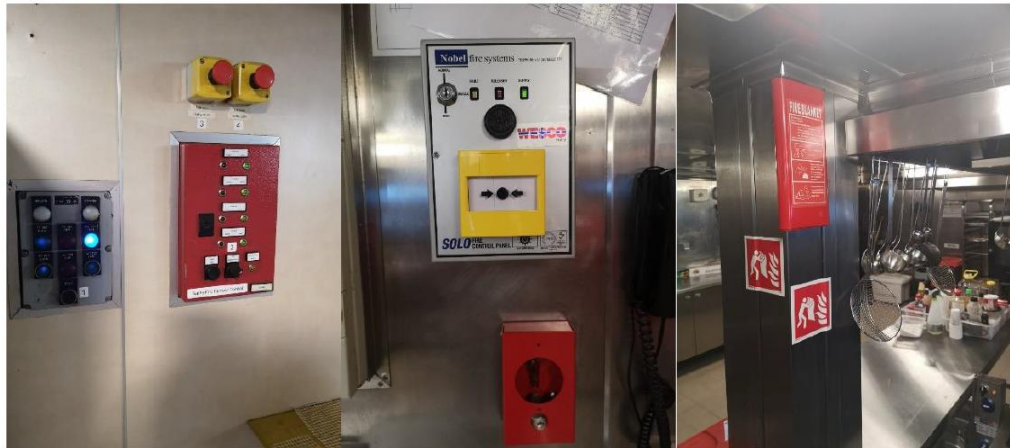
**Galley firefighting systems and emergency stops**

During a recent incident on a members' vessel, the catering crew were found to be unfamiliar with the firefighting systems and electrical equipment emergency stops.

The lack of awareness came to light when there was a water leak in the galley during testing of the vessel's fire pumps. The water leaked into electrical equipment and there was the potential for electrocution of the catering crew. The engine room crew were called and were able to safely isolate the galley electrical systems using the power supply emergency stops. The catering crew however were unfamiliar with the emergency stops.

- ◆ Ensure that all catering personnel complete all mandatory familiarisation on joining the vessel.
- ◆ Review levels of awareness with your catering crew and if required, cause catering crew to repeat appropriate familiarisation.
- ◆ Chief Stewards should regularly emphasise the location and use of galley firefighting systems and emergency stops in daily Toolbox Talks.
- ◆ Maintain galley fire drills, and if necessary, increase the frequency of galley-related fire drills to ensure all catering crew have sufficient awareness **and confidence** to use galley-related firefighting systems and electrical emergency stops for galley equipment.
- ◆ Ensure emergency stops in the galley are fitted, operational, visible, easily accessed and marked appropriately.
