# REPUBLIC OF THE MARSHALL ISLANDS

### NO.2 OCEAN PIONEER MARINE SAFETY INVESTIGATION REPORT

Fatal Enclosed Space Entry

Strait of Hormuz | 25 August 2025

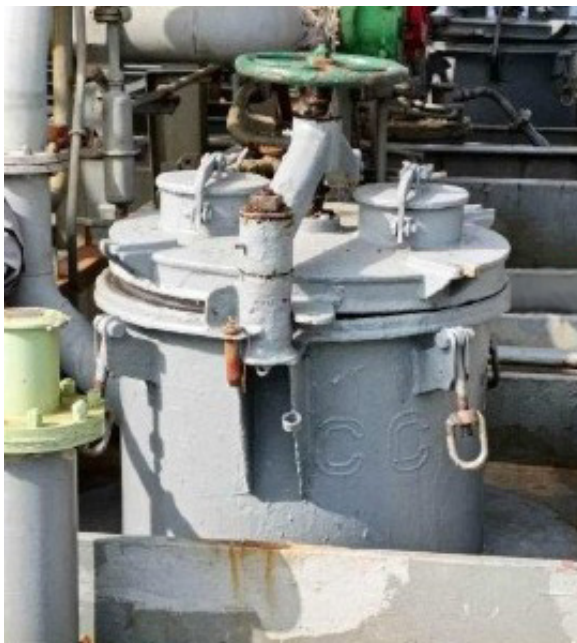
Figure 3: Photograph of a partially open cargo tank dome hatch.

The Company's procedures required that the tank dome hatch be kept closed so that there was sufficient pressure to cause the high-velocity PV valve to open and expel any cargo vapor that might be inside the cargo tanks being gas freed.

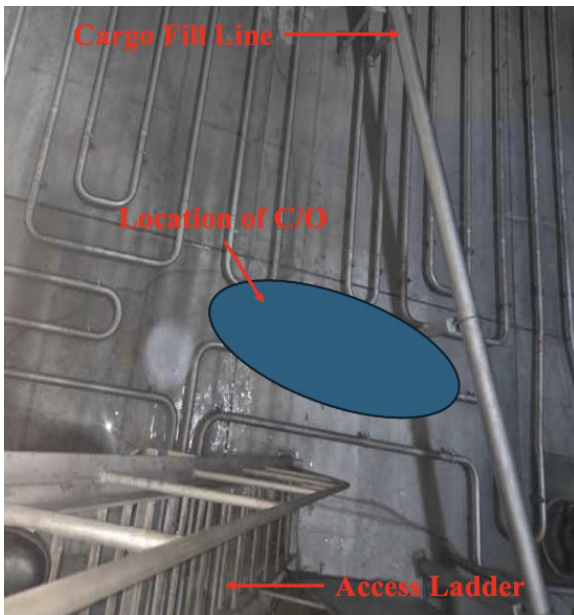
Within five minutes from when the C/O entered No. 3 P CT, the OS1 and A/O, who were on standby next to the tank dome, heard a noise inside the cargo tank. They looked down into the cargo tank and saw the C/O lying on the tank top between the access ladder and the cargo fill line (*see Figure 4*).

Figure 4: Inside of No. 3 P CT showing where the C/O was seen lying on the tank top.

However, the fact that the C/O was unconscious and breathing weakly when the Master reached him indicated that the atmosphere in at least the lower portion of No. 3 P CT was oxygen deficient. This is consistent with the Master reporting that he had difficulty breathing when he was holding the BA set mask on the C/O's face.
