### FEDERAL INDIANA MARINE SAFETY INVESTIGATION REPORT

Occupational Fatality – Connected Space Entry

Mediterranean Sea | 19 February 2025

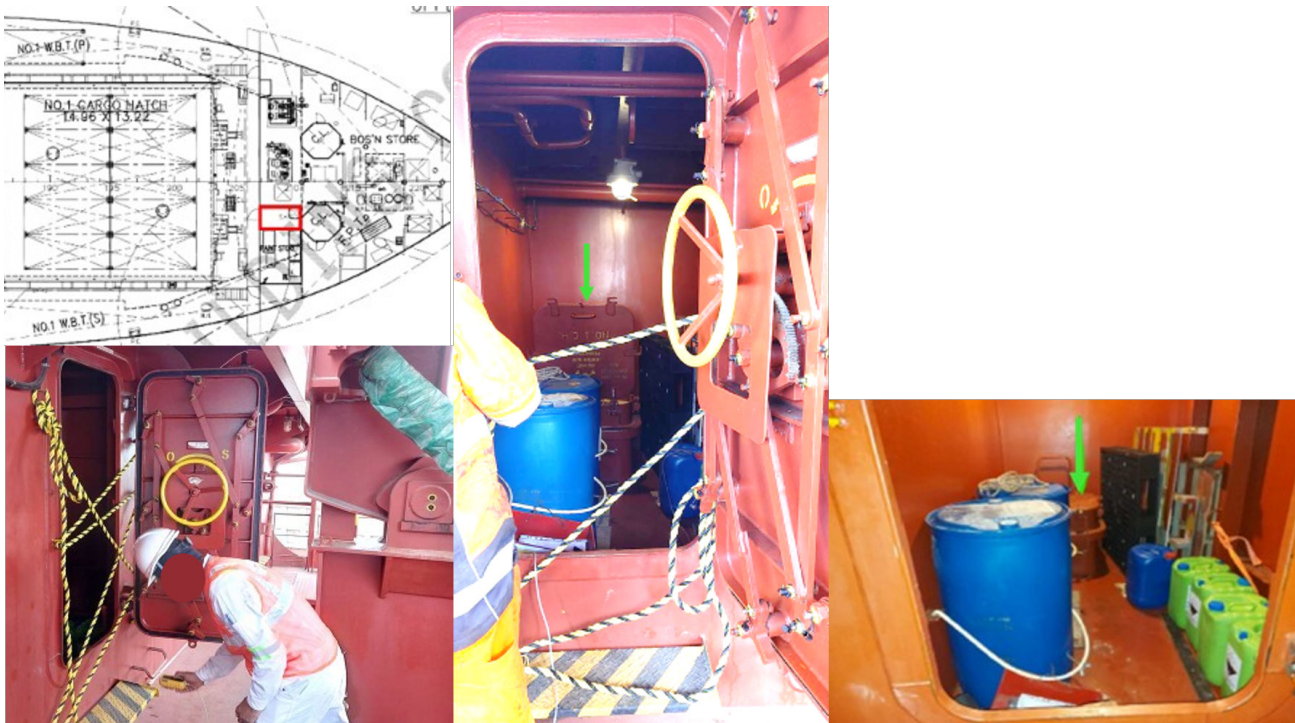
Figure 2: The CH No. 1 Access Space is indicated in red on the General Arrangement. The bottom left picture shows the location of the weather tight access door with the handwheel identified by the yellow circle. The green arrows in the middle and right pictures point to the booby hatch at the back of the space.

Access to the space is through a weathertight door (*see Figure 2*). The space is ventilated by an opening next to the access door (*see Figure 4*). The booby hatch cover is the only separation between CH No. 1 and CH No. 1 Access Space.

FEDERAL INDIANA was designed with the forward booby hatch for CH No. 1 located under the forecastle deck in a small space with no other function and accessed through a weathertight door. This led to the creation of an additional space under the forecastle deck, the CH No. 1 Access Space. The presence of a closed booby hatch cover in combination with natural ventilation led to an underestimation of the possible hazards inside the space.

1. CH No. 1 Access Space has been formally added to the list of connected spaces on board all vessels with a similar structural arrangement.
2. Hydrogen cyanide detection testing tubes have been supplied on board all vessels involved in the loading of scrap cargoes.
3. Owners have mandated strict compliance with IMSBC Code requirements related to loading operations during precipitation.
4. Owners have mandated enhanced inspections of scrap metal cargo prior to and during loading to identify and address any potential hazards or nonconformities.
5. A training video highlighting the hazards associated with adjacent and connected spaces has been developed and issued for mandatory viewing across the fleet.

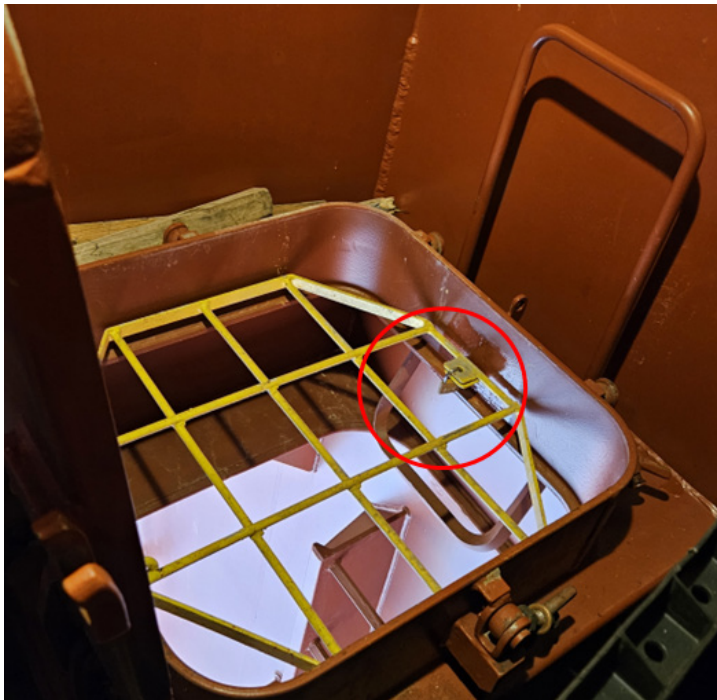
Access to enclosed spaces on board FEDERAL INDIANA were secured and strict procedures were in place to enter an enclosed space. There was an additional procedure for entry into cargo holds<sup>18</sup> that required the booby hatch covers to be locked when closed. This additional procedure required that when booby hatches needed to be opened, a barrier be placed in the opened booby hatch and secured with a padlock, to prevent unauthorized access (*see Figure 3*).

Figure 3: Secured grid (barrier) in the forward booby hatch of CH No. 1.

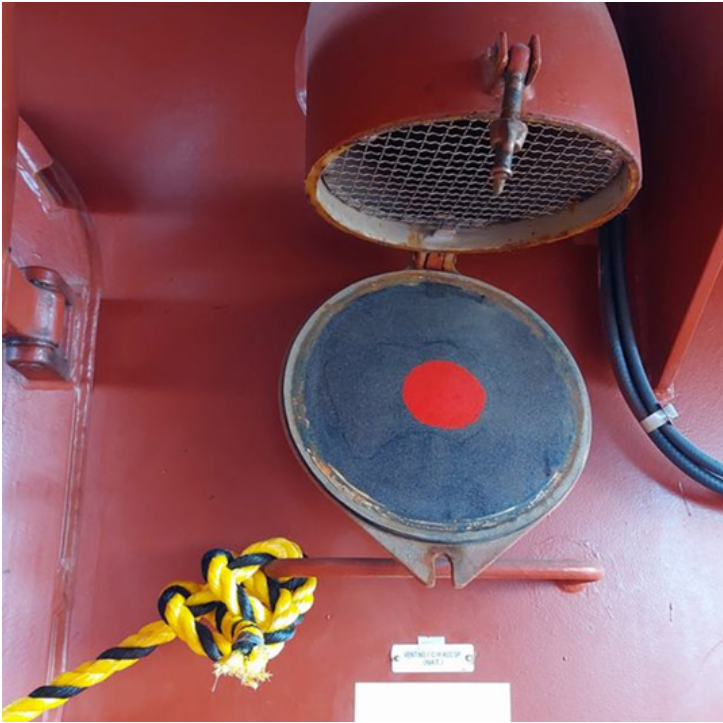
Figure 4: Ventilation of the CH No. 1 Access Space.

Consistent with IMO Resolution A.1050(27), the CH No. 1 Access Space on board FEDERAL INDIANA, being naturally ventilated, was not classified as an enclosed space. The same principle was applied on board other ships in the Company’s managed fleet where access hatches to cargo holds were located inside other structures, such as crane foundations.
