### AVRA MARINE SAFETY INVESTIGATION REPORT

Fatality During Enclosed Space Entry

Daesan Port, Republic of Korea | 25 July 2025

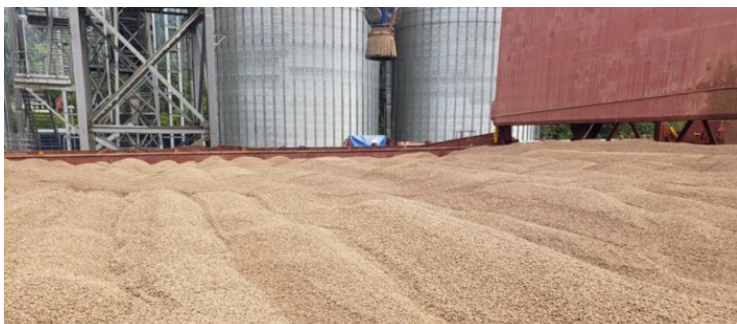
Figure 2: Wood pellets shown here in the cargo hold with the hatch cover opened.

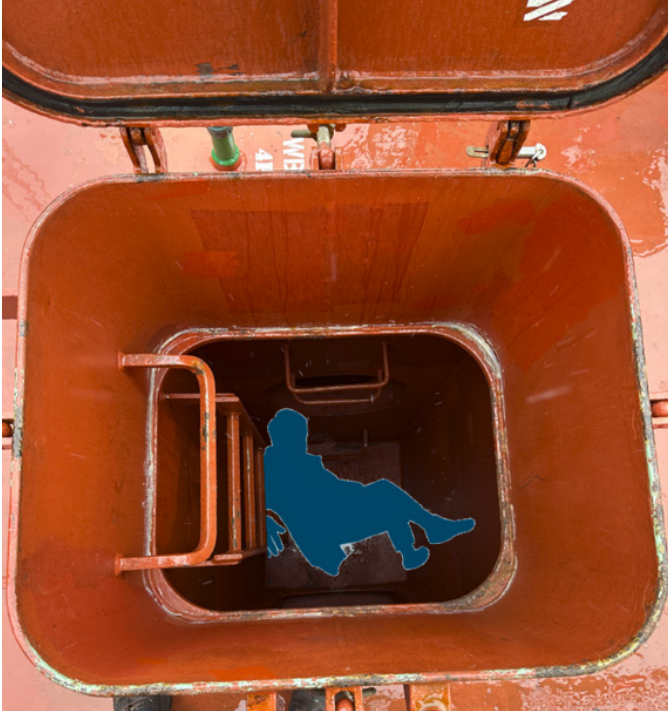
At about 1020, the C/O proceeded to the main deck to look for the Bosun. The C/O was walking forward on the port side of the main deck when he noticed the CH No. 4 aft access hatch cover was open. The C/O looked down through the open access hatch and saw the Bosun lying inside the CH No. 4 aft access hatch space (see Figure 3).

Figure 3: CH No. 4 aft access hatch space showing where the C/O saw the Bosun lying (as illustrated).

The Bosun was found unconscious and unresponsive at the bottom of the CH No. 4 aft access hatch space, where carbon monoxide levels measured 40 ppm and the oxygen concentration was 16.7%. It was likely that, in the section of the access hatch space where the Bosun had been removing the securing nuts to the manhole, the carbon monoxide levels would have been higher and the oxygen concentration significantly lower. The Bosun would likely have felt the effects of carbon monoxide poisoning and oxygen deficiency and may have attempted to exit the access space in the vicinity of the manhole before succumbing to asphyxiation in the CH No. 4 aft access hatch space.

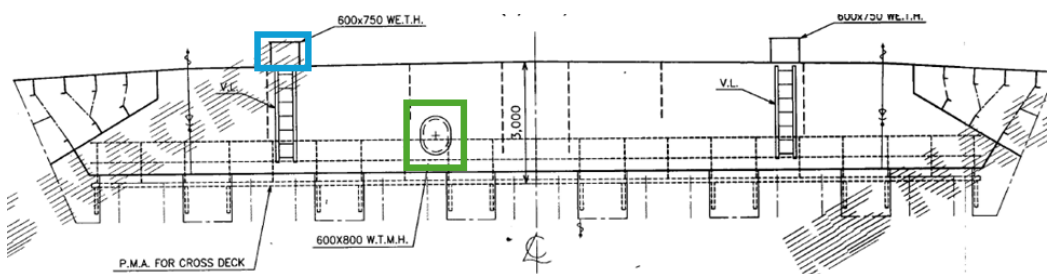
Figure 4: The cross-sectional view (viewed from aft) of the access space, the blue border indicates the CH No. 4 aft access hatch. The green border indicates the manhole for accessing the CH Nos. 4 and 5 inspection platforms.

After entering the CH No. 4 aft access hatch space and working on removing the securing nuts of the manhole, an opening (see Figure 4) that led into the CH No. 5 forward inspection platform, the Bosun had exposed himself to toxic levels of carbon monoxide and to an oxygen deficient environment.

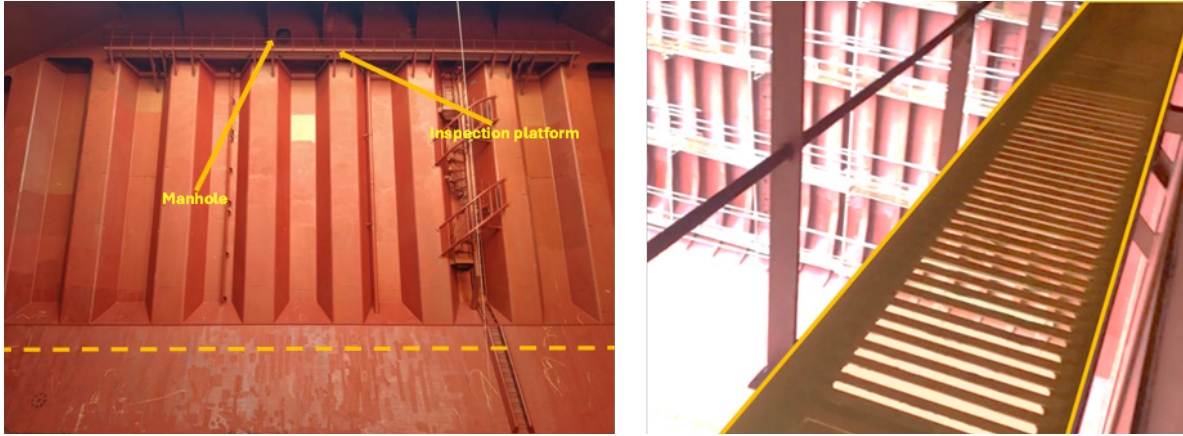
Figure 5: CH No. 5 aft bulkhead (left photo) showing the location of the inspection platform and the manhole for accessing the inspection platform from the access space. The dotted line represents the cargo level (at the bottom hopper) inside the cargo hold on the morning of 25 July 2025. The right photo shows the inspection platform with the area on the walkway where cargo residues accumulated (shaded and outlined in yellow).

On the morning of 25 July 2025, cargo was being discharged from CH Nos. 1, 3, and 5. The Bosun, who was on deck at this time, would have been aware that cargo was being discharged from these cargo holds. The hatch covers for CH Nos. 2 and 4, which were both filled with wood pellets, were closed. The Bosun would also have been aware that CH Nos. 2 and 4 were both filled and that the hatch covers were closed. At this time, the cargo of wood pellets inside CH No. 5 had already been discharged to the bottom hopper level (*see Figure 5*).

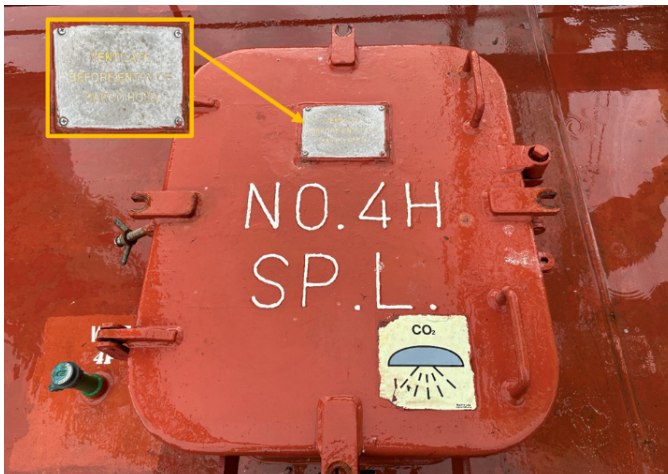
The CH No. 4 aft access hatch cover was marked, “NO. 4H SP. L.” This indicated that the access hatch was the entry into CH No. 4. There was also a small metal plate with the warning: “VENTILATE BEFORE ENTRY OF CARGO HOLD” (see Figure 6). The text on the plate was worn and not easily legible.

Figure 6: CH No. 4 aft access hatch cover.

Apart from the existing warning sign on the access hatch cover (*see Figure 6*), the Shipper's recommended safety precautions advisory to label "Low Oxygen Risk Area" was not present on the cargo hold's access hatch cover.

<sup>22</sup> *See Figure 6* highlighting the small metal plate.

- (e) improves the existing warning signage to indicate the hazards contained within each enclosed and connected space and add physical barriers to prevent unauthorized entry into the access hatch space of cargo holds.

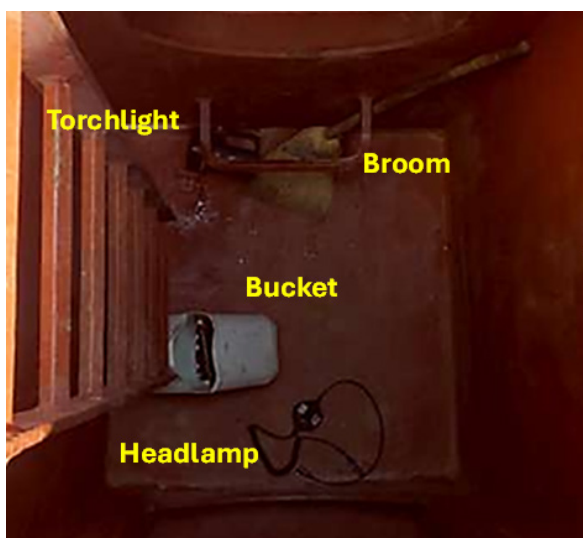
After the Bosun had been evacuated from the CH No. 4 aft access hatch space, crewmembers found a torchlight, a headlamp, a broom, a bucket containing a spanner, and about 25 securing nuts at the bottom of the access ladder (see Figure 7). The manhole cover for accessing the CH No. 5 inspection platform was found in place with the 25 securing nuts removed. The Bosun's walkie talkie was retrieved from the access space by the 3/O during the rescue.

Figure 7: Items found in CH No. 4 aft access hatch space.
