SAFETY INVESTIGATION REPORT

REPORT NO.: 22/2018

MV BOZDAG **Deck slewing crane failure** **in the port of Tallinn** **28 November 2017**

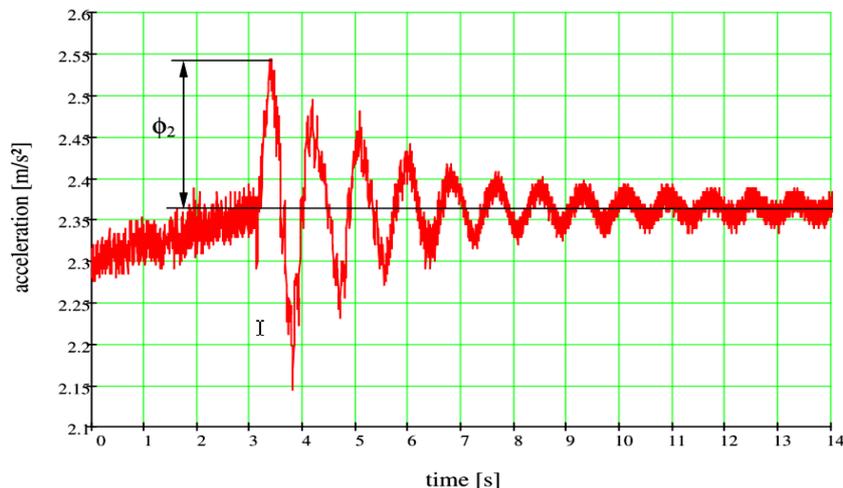
Figure 3: An example of a typical dynamic overload due to stoppage of lifting motion

As it can be seen in Figure 3, most of the oscillations have peak amplitudes during the beginning or at the end of the motion of the load. Such oscillations, in turn, would increase the load, which acts on the structure itself. The symbol ϕ_2 in the figure represents the dynamical overloading.

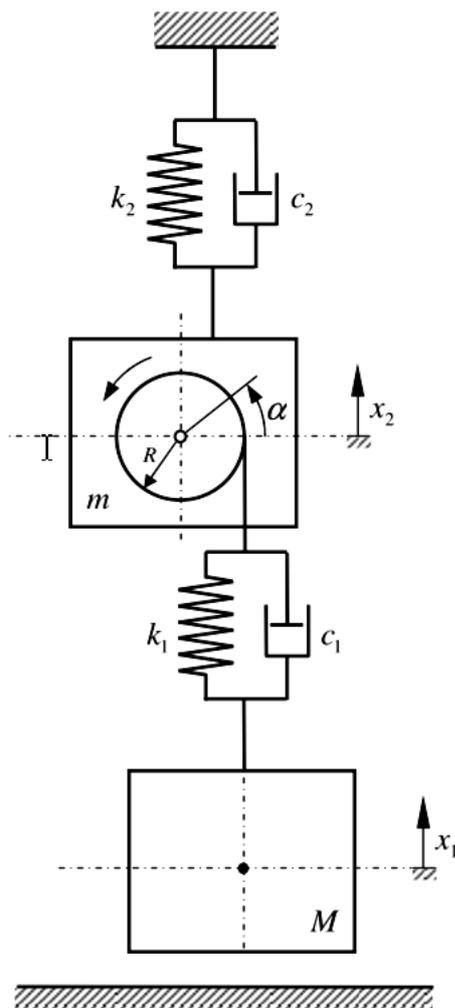
Figure 4: Schematic diagram of loading during lifting/lowering motion

Figure 4 indicates that two degrees of freedom are allowed due to the vertical motion of the load and rotational motion of the drum. The vertical motion of the load is represented by the linear displacement variable x_1 . The displacement of the structure due to oscillations is represented by the linear displacement variable x_2 .

'M' and 'm' represent the masses of the load and the lifting structure respectively. Due to the oscillatory motion, which causes vibrations in both the deck slewing crane structure and the cable, a damping and stiffness constant are added to both structure and cable, where 'k' represents the stiffness values and 'C' the damping factor. 'C₁' and 'C₂' represent the relevant values for the cable and the deck slewing crane structure respectively⁴.

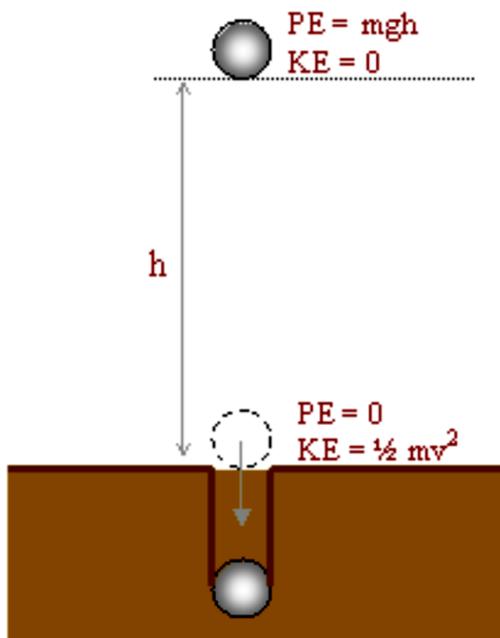
Figure 5: Diagram showing the impact force from a free falling object [4]

During the process of free falling, the potential energy (PE) due to gravity of an object is converted into kinetic energy (KE) (Figure 5)⁶.
