Report on the investigation of  
the engine failure and fire on board  
the ro-ro cargo vessel

***Finlandia Seaways***

11 miles east of Lowestoft

16 April 2018

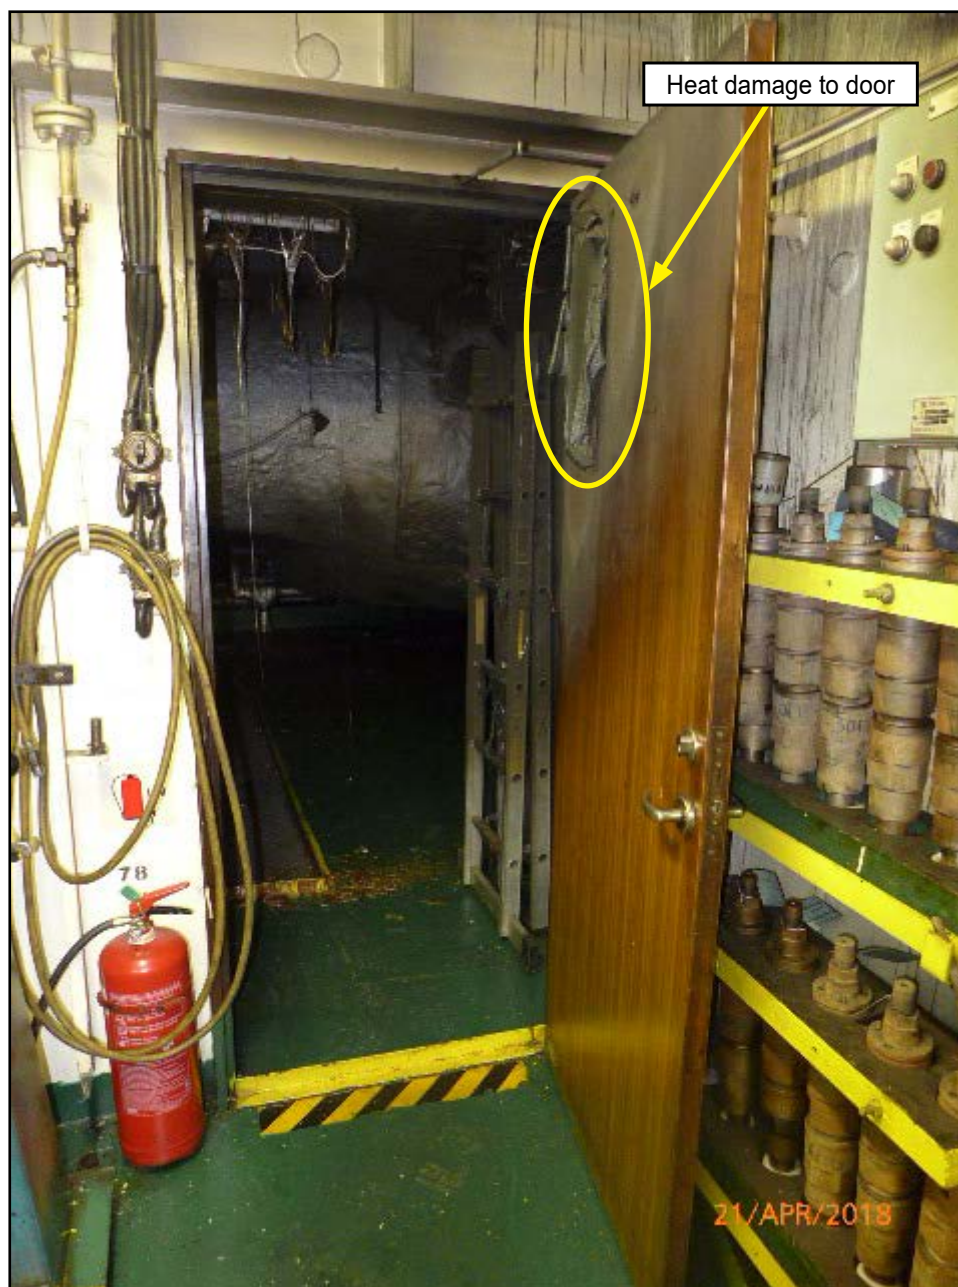
**Figure 3:** Purifier room door

The 3/E opened the purifier room door, looked out into the engine room and saw smoke rising from the port forward end of the main engine. The noise and vibration levels rapidly increased and, sensing danger, the 3/E ran back into the purifier room and crouched behind one of the purifiers. Almost immediately, at 2003, there was a loud bang and flames flashed past the open purifier room door (**Figure 3**) and the space filled with thick black smoke. The ship blacked out<sup>1</sup>, but within seconds the emergency generator cut-in and the emergency lighting came on. Despite this, the smoke in the engine room had reduced the 3/E's visibility to almost nothing.

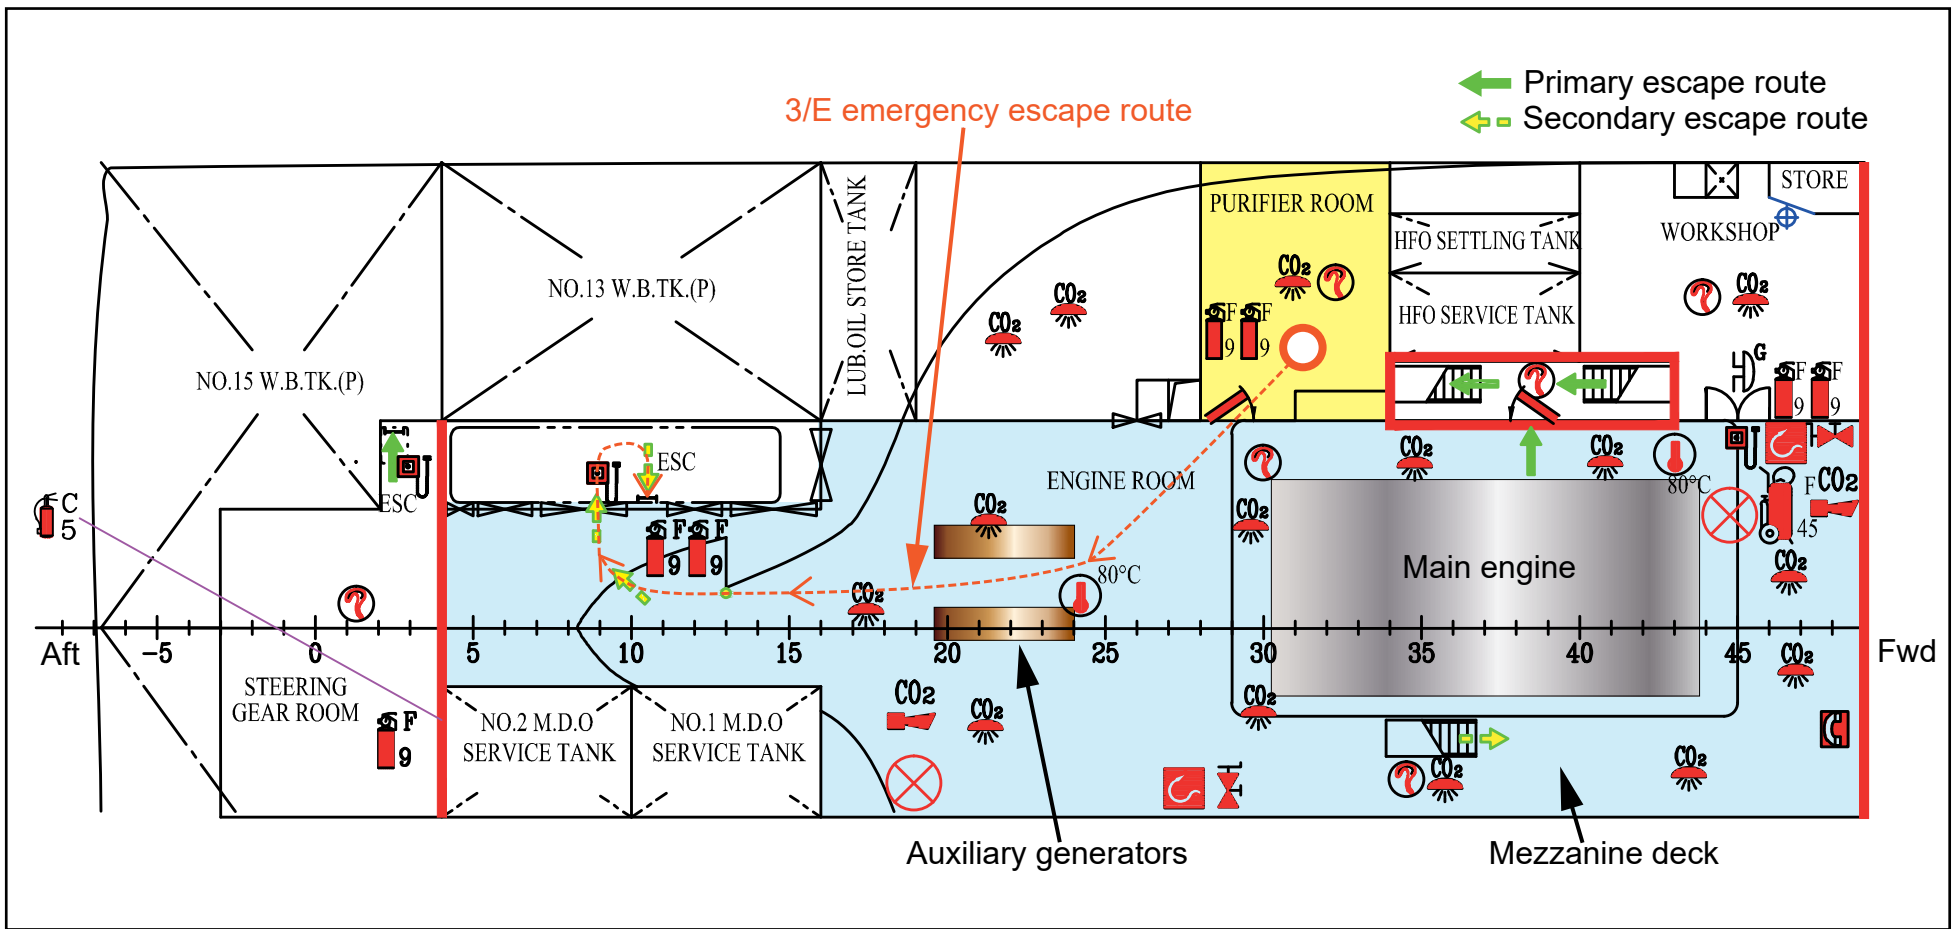
Figure 6: Purifier room and engine room tween deck (shaded blue) with 3/E's escape route

In the purifier room, the 3/E realised that his nearest escape route would take him past the main engine at cylinder head level and decided to use the secondary escape route at the aft end of the engine room (**Figure 6**). He took a deep breath and then left the purifier room. On entering the dense black smoke, the 3/E ducked underneath the main engine exhaust gas trunking and ran aft past the two auxiliary generators. The escape route (**Figure 7**) led him to the first of three vertical ladders (**Figure 8**). When he climbed the first ladder, he struggled to get past the ladder platform guard rail safety chains and fell back down the ladder three times, losing his torch in the process, before making good his escape.

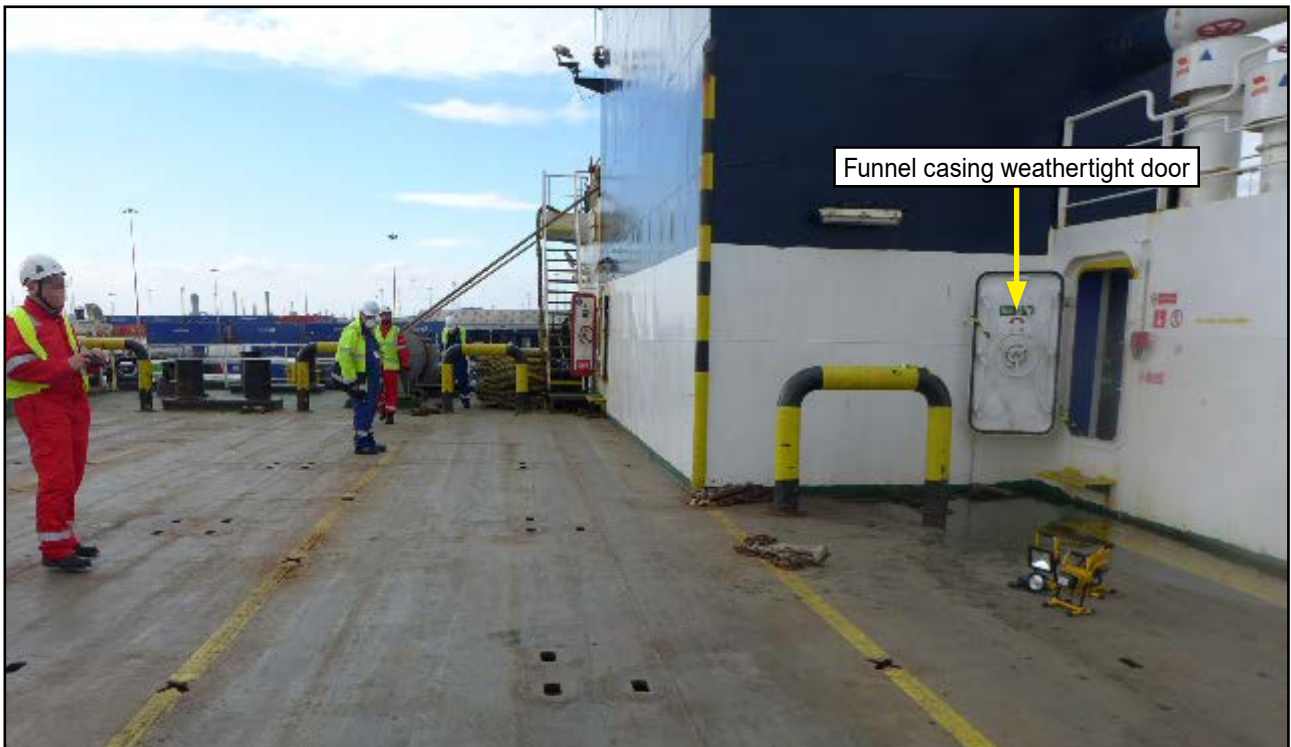
**Figure 9:** Upper vehicle deck

At 2013, the 3/E escaped from the engine room through the funnel casing weathertight door onto the upper vehicle deck (**Figure 9**). He then collapsed onto the deck, gasping for breath and struggling to see. The 2/E saw the 3/E collapse and went to help him. The 2/E radioed the bridge and informed the master that the 3/E required medical assistance. At 2015, on instruction from the master, the OOW contacted Humber Coastguard and requested a helicopter.

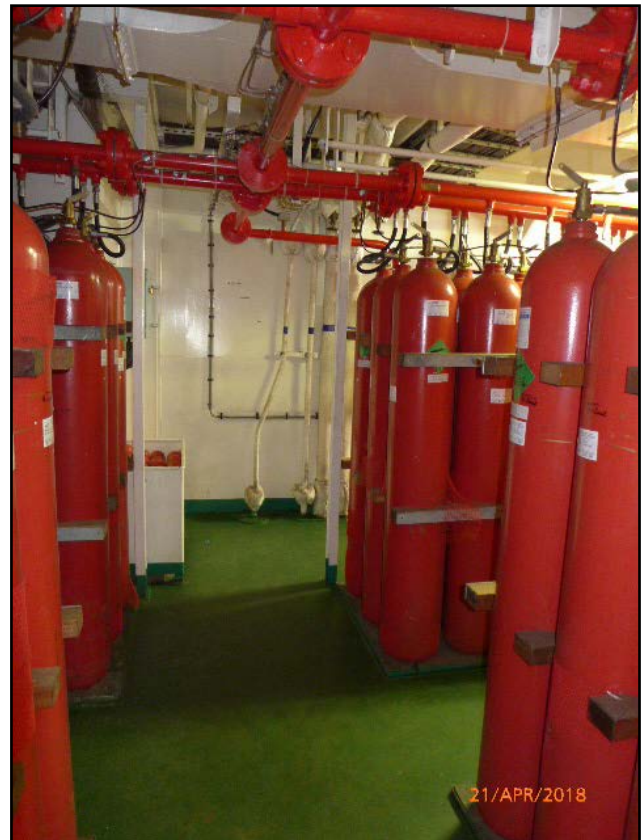
**Figure 11:** CO<sub>2</sub> bottle room

The 2/E and the second officer went to the CO<sub>2</sub> remote release station (**Figure 10**) on the forecastle deck and, at about 2020, released the CO<sub>2</sub> into the engine room. The 2/E then went down to the main deck and entered the CO<sub>2</sub> bottle room (**Figure 11**). He found that the control lever for the engine room had operated correctly and that the CO<sub>2</sub> pipework had frosted. He also noted that the main CO<sub>2</sub> supply line pressure gauge was indicating about 20bar pressure, and a short time later he saw it reduce to zero.

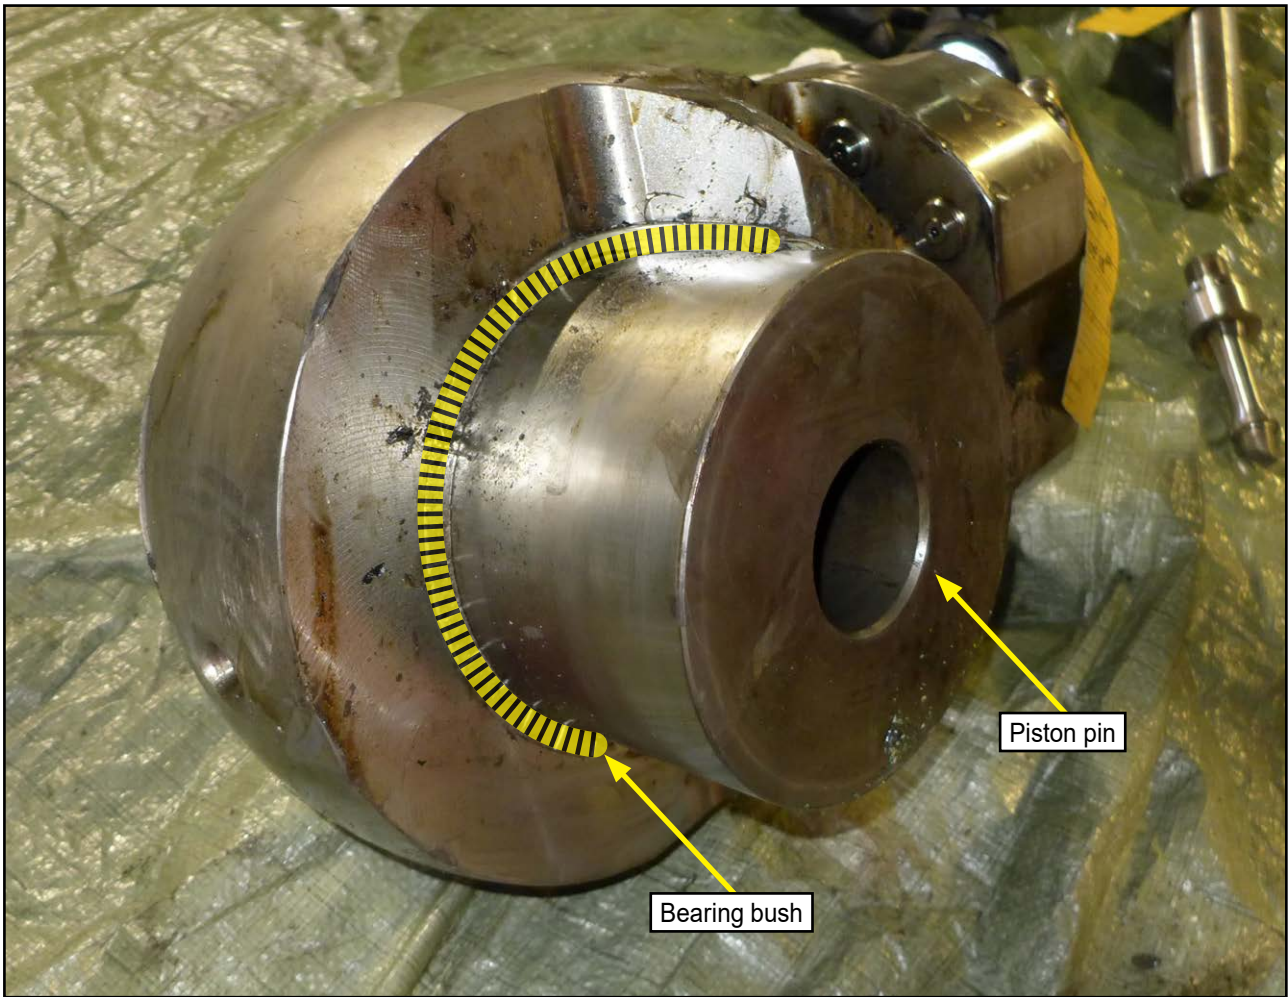
**Figure 15:** B5 small end with piston pin

installed into the eye of the small end (**Figure 15**). The surface finish of the inner face of the small end eye was prepared during manufacture by shot-peening<sup>5</sup> to reduce the potential for fatigue fractures developing under high operational loads.

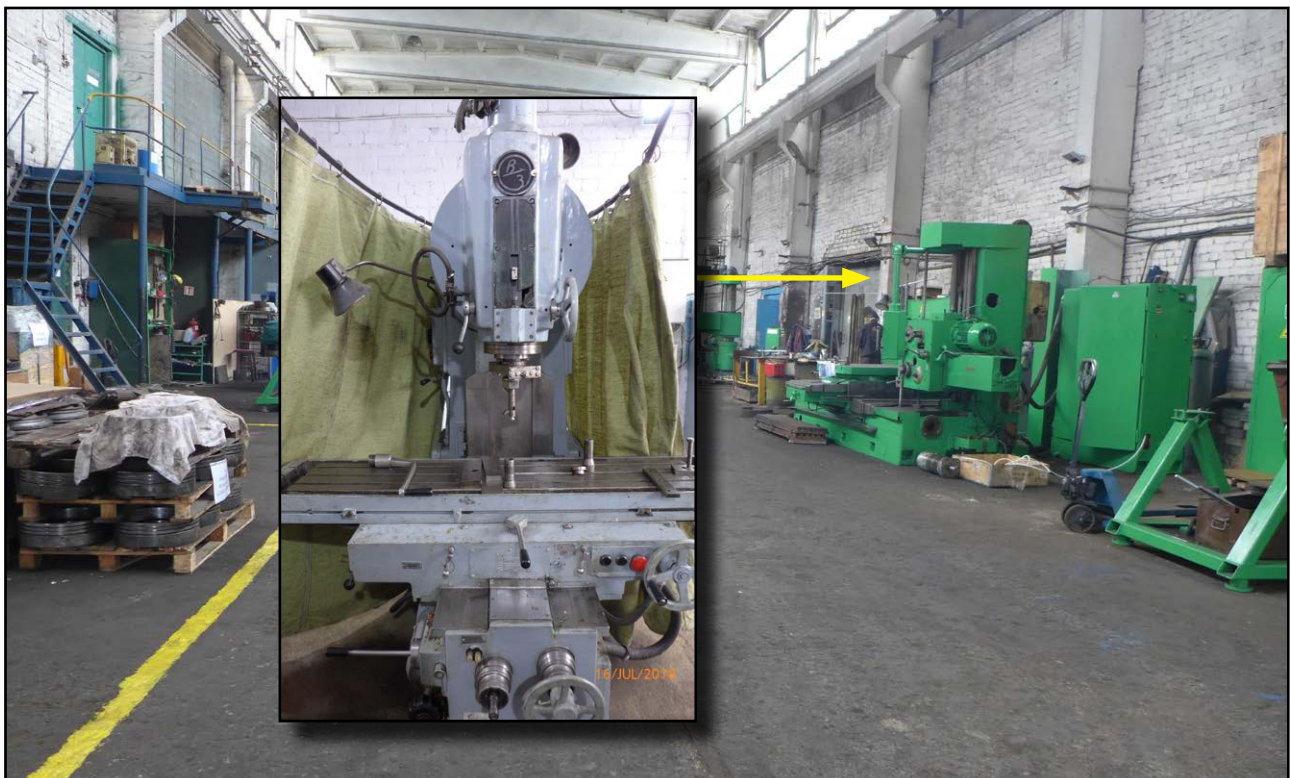
**Figure 23:** Diesel Service Group workshop and milling machine (inset)

The removal and installation of the MAN connecting rod piston pin bushes was carried out by DSG at its workshops in Klaipeda (**Figure 23**). DSG's documented *piston pin bush removing and installing* procedure for the MAN 12V 48/60 engine (**Figure 24**) was similar to that followed by MAN. To remove the piston pin bush in accordance with the procedure, one side of the bush had to be bored away using a milling machine before pressing it out. The new bush needed to be cooled using liquid nitrogen to  $-195^{\circ}\text{C}$  and measured before being inserted into the small end eye; a specialist tool was required to be used when aligning the bush.

DSG employed one person to oversee the work and produce the technical repair document, and only one technician was permitted to use the milling machine. DSG was unable to confirm whether anyone else, including possible subcontractors, had undertaken this work.

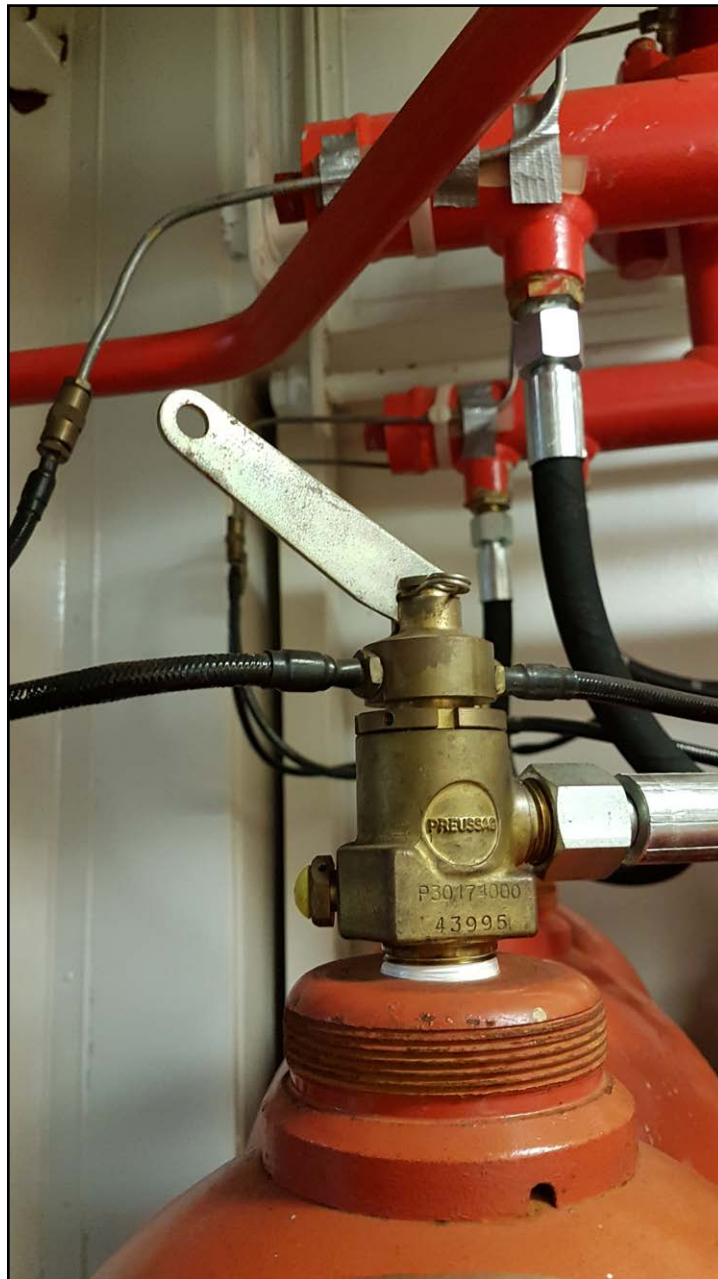
**Figure 28:** Carbon dioxide bottle operating valve

Confirmation that CO<sub>2</sub> had been released into the protected space was achieved by entering the CO<sub>2</sub> bottle room and checking the appropriate control valve had activated and the manifold gas pressure gauge had dropped to zero. Frosting of the bottles and manifold pipes provided a further visual indication that gas had been released. Information to enable the crew to easily identify which spaces individual CO<sub>2</sub> bottles protected was not provided in the bottle room, and the gas bottle operating valves did not provide a visible means of identifying whether they were open or closed (**Figure 28**).

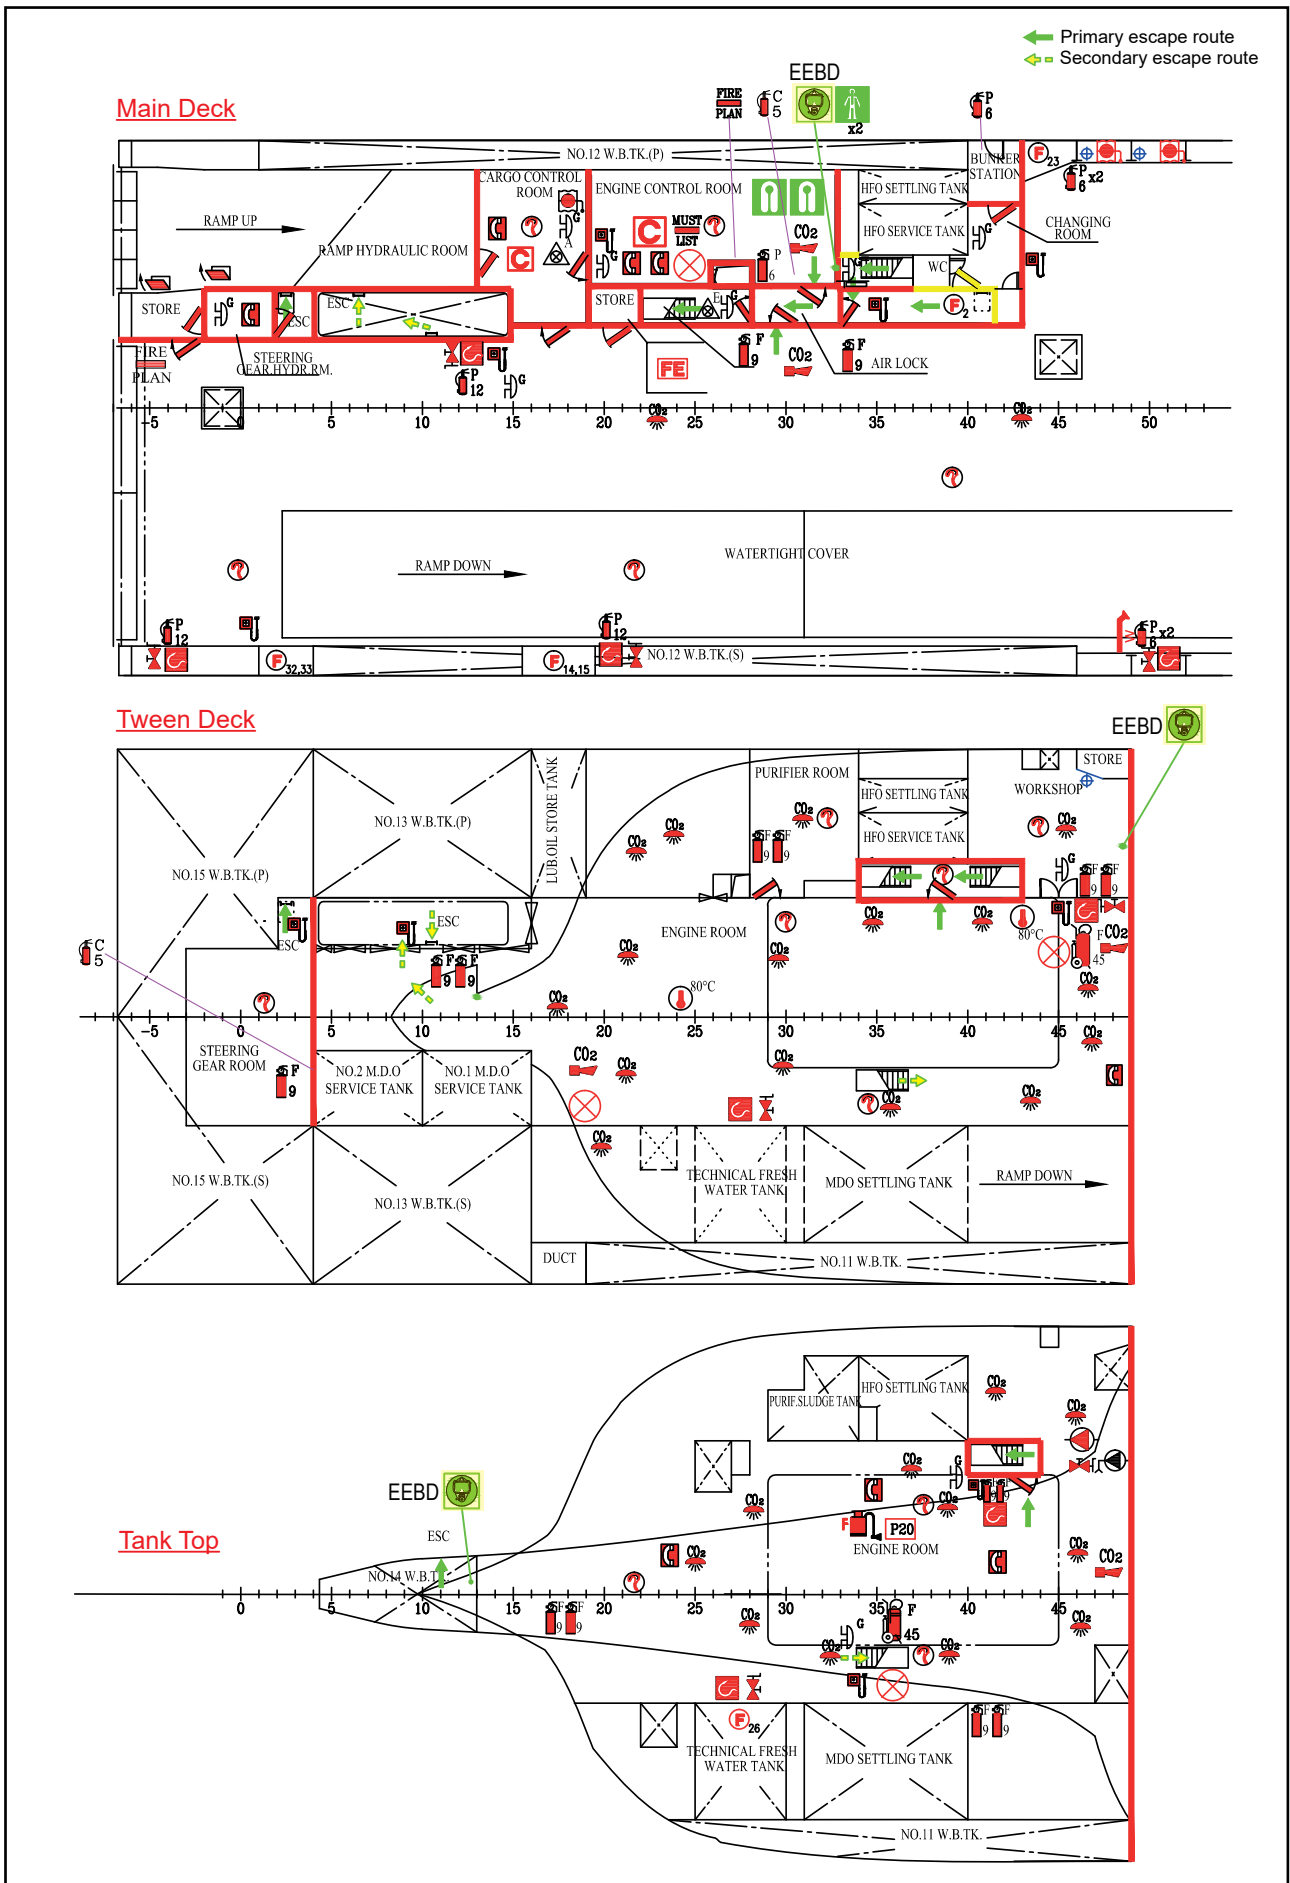
Figure 29: Distribution of EEBDs in or near the engine room and escape routes

*Finlandia Seaways* met the means of escape requirements, with the continuous fire protection route being the primary escape route via the steel self-closing door at the port-forward bottom engine deck, up the enclosed stairwell via the control room and to the main deck (**Figure 29**).

The secondary means of escape, as used by the 3/E, via the funnel casing aft of the generators, was not enclosed. This route could be accessed from the bottom engine room deck, via a steel ladder near the propeller shaft on the port side, and up through a hinged steel hatch grating at generator deck level.
