### AVRA MARINE SAFETY INVESTIGATION REPORT

Fatality During Enclosed Space Entry

Daesan Port, Republic of Korea | 25 July 2025

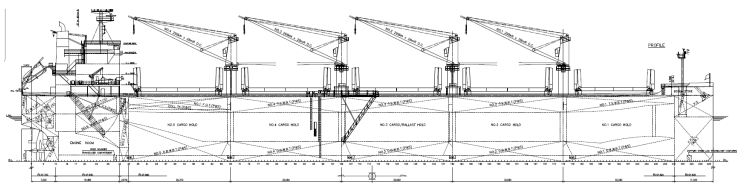
Figure 1: AVRA General Arrangement.

On the morning of 25 July 2025, the geared five-hatch, bulk carrier AVRA (*see Figure 1*) was berthed on the starboard side at MB5, Daesan Port, and was discharging the bulk cargo of wood pellets. At 1015, wood pellets were being discharged from CH Nos. 1, 3, and 5, with the hatch covers in the open position (*see Figure 2*). The hatch covers for CH Nos. 2 and 4, both fully loaded with wood pellets, remained closed. The C/O, who was in the ship's office, called the Bosun on the walkie talkie but did not receive a response. The C/O then instructed the 3/O to call the Bosun on his cabin telephone and checked with the duty ASD regarding the Bosun's whereabouts. After receiving no answer from the Bosun's cabin telephone, the 3/O made an announcement on the ship's public address, but there was no reply from the Bosun. The duty ASD reported to the C/O that he had not seen the Bosun.
